Access Compliance Report

Public Rights-of-Way (Curb Ramps)

Intersection ID: 3857	Main Street: MOUNTAIN_PARK_DR	Cross Street: MOUNTAIN_TRAIL_DR	Location: NW
ADA ID: 3D1828429D36	Ramp Type: PerpDiag	Initial Pass/Fail: Fail	Overall Compliance: No
			Severity Score: 13.75

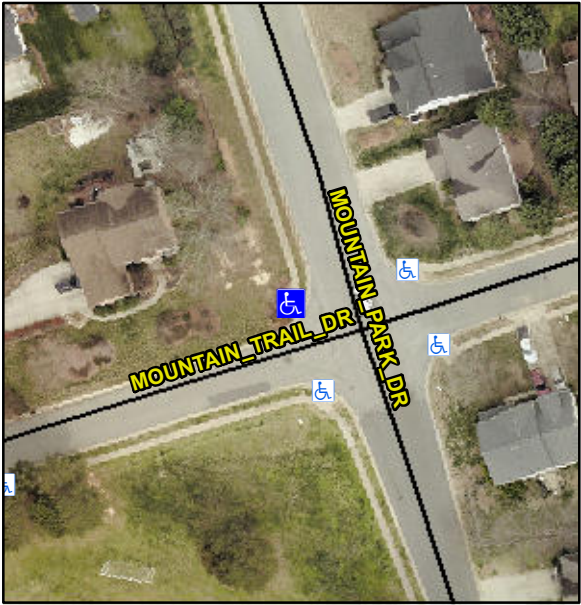
<p>Street 1 Name MOUNTAIN TRAIL DR</p> <p>Stop Condition-Street 2 StopSign</p> <p>Street 2 Name MOUNTAIN PARK DR</p> <p>Stop Condition-Street 1 None</p>	Possible Solutions:				
	Remove & Replace Curb Ramp With Two New Directional Ramps or Equivalent.				
	Surveyor Notes:				
	N/A				
	PROW/ADA:				
	R304.2.2, R304.5.3				
	Total Cost:	\$	3200.00		
Compliance	Description	Data	Compliance	Description	Data
N/A	Ramp Length (in)	53.0	No	Ramp Slope (%)	9.1
Yes	Ramp Width (in)	48.0	No	Ramp XSlope (%)	4.6
N/A	Flare Type LT	N/A	N/A	Flare Type RT	N/A
N/A	Flare Slope LT (%)	N/A	N/A	Flare Slope RT (%)	N/A
N/A	Flare Traversable LT?	N/A	N/A	Flare Traversable RT?	N/A
N/A	Landing Length (in)	N/A	N/A	DWS Provided?	N/A
N/A	Landing Width (in)	N/A	N/A	DWS Contrast?	N/A
N/A	Landing Slope (%)	N/A	N/A	DWS Length (in)	N/A
N/A	Landing X Slope (%)	N/A	N/A	DWS Full Width?	N/A
