Access Compliance Report

Public Rights-of-Way

(Curb Ramps)

Intersection ID: 9814	Main Street: CLIFTON_ST	Cross Street: PATTON_AV	Location: W
ADA ID: 3D1BB17393D8	Ramp Type: PerpDiag	Initial Pass/Fail: Fail	Overall Compliance: No
		Severity Score: 10

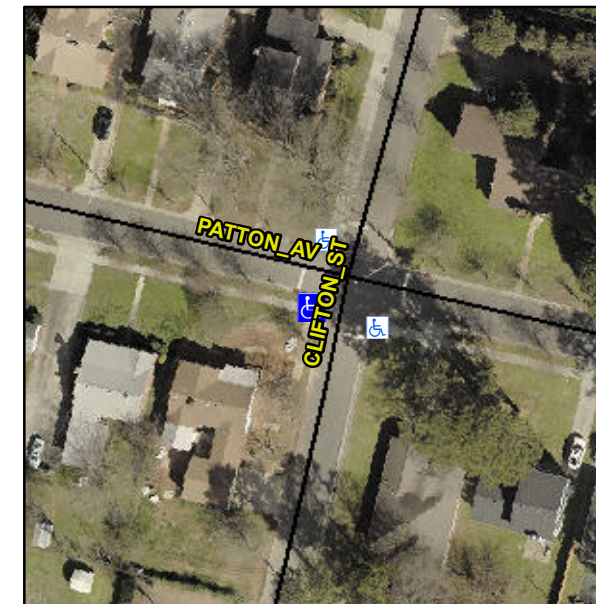
Not Found, R304.5.1, R304.5.3

Compliance	Description	Data	Compliance	Description	Data
N/A	Ramp Length (in)	48.5	Yes	Ramp Slope (%)	7.3
No	Ramp Width (in)	47.0	No	Ramp XSlope (%)	3.3
N/A	Flare Type LT	N/A	N/A	Flare Type RT	N/A
N/A	Flare Slope LT (%)	N/A	N/A	Flare Slope RT (%)	N/A
N/A	Flare Traversable LT?	N/A	N/A	Flare Traversable RT?	N/A
N/A	Landing Length (in)	N/A	N/A	DWS Provided?	N/A
N/A	Landing Width (in)	N/A	N/A	DWS Contrast?	N/A
N/A	Landing Slope (%)	N/A	N/A	DWS Length (in)	N/A
N/A	Landing X Slope (%)	N/A	N/A	DWS Full Width?	N/A
N/A	Landing Curb? (Y/N)	N/A	N/A	DWS Offset (in)	N/A
N/A	Shared Landing?	N/A			
N/A	Gutter Ponding?	N/A	N/A	Gutter Slope (%)	N/A
N/A	Gutter Lip Ht (in)	N/A	N/A	Gutter X Slope (%)	N/A
N/A	Painted X Walk1?	No	N/A	Painted X Walk2?	No
	X Walk 1 Direction	To SE		X Walk 2 Direction	To NE
N/A	X Walk 1 Width (in)	N/A	N/A	X Walk 2 Width (in)	N/A
	X Walk 1 Slope (%)	0.3		X Walk 2 Slope (%)	4.6
	X Walk 1 X Slope (%)	2.9		X Walk 2 X Slope (%)	0.8

N/A	Ramp inside XWalk1?	N/A	N/A	Ramp inside XWalk2?	N/A
	Road Slope (%)	2.0	N/A	Clear Space?	N/A
	Road X Slope (%)	1.3	N/A	Clear Space to XWalk (in)	N/A
N/A	Any Obstructions?	N/A	N/A	Storm Grate/Utility Hazard?	N/A
	Obstruction Type			Storm Grate/Utility Type	
		N/A			N/A
			Yes	Surface Condition? (G/P)	Good

Remove & Replace Curb Ramp With Two New Directional Ramps or Equivalent.

Total Cost: \$ 3200.00
