Access Compliance Report

Public Rights-of-Way

(Curb Ramps)

Intersection ID: 27446	Main Street: BALLANTYNE_MEADOWS_DR	Cross Street: VALLEY_SPRING_DR	Location:	N
ADA ID: 3D244FBB1327	Ramp Type: PerpDiag	Initial Pass/Fail: Fail	Overall Compliance: No	Severity Score: 12.5
Codes/Mitigation Info/Possible Solution		Field Measurements/Component Compliance

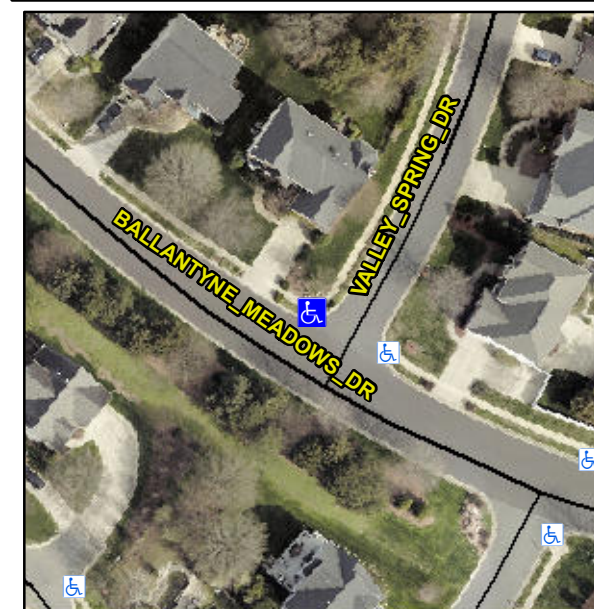
Not Found, R304.2.2

Compliance	Description	Data	Compliance	Description	Data
N/A	Ramp Length (in)	41.0	No	Ramp Slope (%)	8.5
Yes	Ramp Width (in)	48.0	Yes	Ramp XSlope (%)	2.0
N/A	Flare Type LT	N/A	N/A	Flare Type RT	N/A
N/A	Flare Slope LT (%)	N/A	N/A	Flare Slope RT (%)	N/A
N/A	Flare Traversable LT?	N/A	N/A	Flare Traversable RT?	N/A
N/A	Landing Length (in)	N/A	N/A	DWS Provided?	N/A
N/A	Landing Width (in)	N/A	N/A	DWS Contrast?	N/A
N/A	Landing Slope (%)	N/A	N/A	DWS Length (in)	N/A
N/A	Landing X Slope (%)	N/A	N/A	DWS Full Width?	N/A
N/A	Landing Curb? (Y/N)	N/A	N/A	DWS Offset (in)	N/A
N/A	Shared Landing?	N/A			
N/A	Gutter Ponding?	N/A	N/A	Gutter Slope (%)	N/A
N/A	Gutter Lip Ht (in)	N/A	N/A	Gutter X Slope (%)	N/A
N/A	Painted X Walk1?	No	N/A	Painted X Walk2?	No
	X Walk 1 Direction	To SW		X Walk 2 Direction	To SE
N/A	X Walk 1 Width (in)	N/A	N/A	X Walk 2 Width (in)	N/A
	X Walk 1 Slope (%)	3.4		X Walk 2 Slope (%)	1.7
	X Walk 1 X Slope (%)	2.9		X Walk 2 X Slope (%)	0.8

N/A	Ramp inside XWalk1?	N/A	N/A	Ramp inside XWalk2?	N/A
	Road Slope (%)	0.5	N/A	Clear Space?	N/A
	Road X Slope (%)	3.2	N/A	Clear Space to XWalk (in)	N/A
N/A	Any Obstructions?	N/A	N/A	Storm Grate/Utility Hazard?	N/A
	Obstruction Type			Storm Grate/Utility Type	
		N/A			N/A
			Yes	Surface Condition? (G/P)	Good

Remove & Replace Curb Ramp With Two New Directional Ramps or Equivalent.
