# Access Compliance Report

## Public Rights-of-Way

### (Curb Ramps)

Intersection ID: 43525	Main Street: MILHAVEN_LN	Cross Street: TANAGER_PARK_DR	Location: NW
ADA ID: 3D25F3513BE7	Ramp Type: Para	Initial Pass/Fail: Fail	Overall Compliance: No
Severity Score: 13.75			
Codes/Mitigation Info/Possible Solution		Field Measurements/Component Compliance

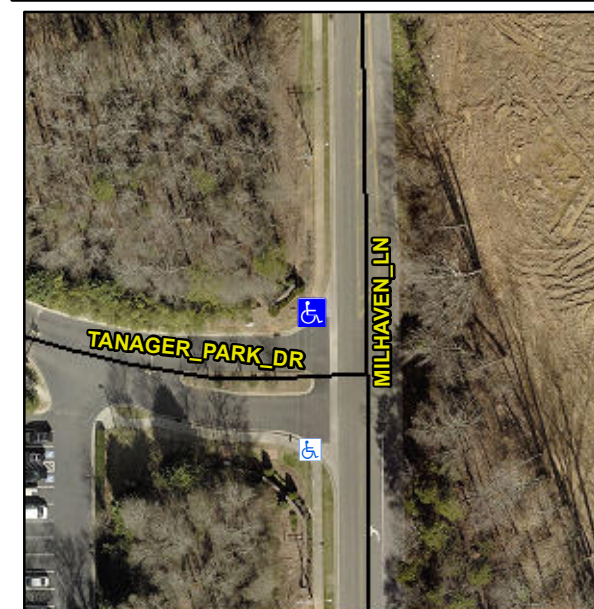
Compliance	Description	Data	Compliance	Description	Data
N/A	Ramp Length LT (in)	57.0	N/A	Ramp Length RT (in)	108.0
Yes	Ramp Width LT (in)	60.0	Yes	Ramp Width RT (in)	59.5
No	Ramp Slope LT (%)	8.7	Yes	Ramp Slope RT (%)	7.9
No	Ramp XSlope LT (%)	2.4	Yes	Ramp XSlope RT (%)	0.7
N/A	Landing Length (in)	N/A	N/A	DWS Provided?	N/A
N/A	Landing Width (in)	N/A	N/A	DWS Contrast?	N/A
N/A	Landing Slope (%)	N/A	N/A	DWS Length (in)	N/A
N/A	Landing X Slope (%)	N/A	N/A	DWS Full Width?	N/A
N/A	Landing Curb? (Y/N)	N/A	N/A	DWS Offset (in)	N/A
N/A	Shared Landing?	N/A			
N/A	Gutter Ponding?	N/A	N/A	Gutter Slope (%)	N/A
N/A	Gutter Lip Ht (in)	N/A	N/A	Gutter X Slope (%)	N/A
N/A	Painted X Walk1?	No	N/A	Painted X Walk2?	N/A
	X Walk 1 Direction	To S		X Walk 2 Direction	N/A
N/A	X Walk 1 Width (in)	N/A	N/A	X Walk 2 Width (in)	N/A
	X Walk 1 Slope (%)	1.0		X Walk 2 Slope (%)	N/A
	X Walk 1 X Slope (%)	0.3		X Walk 2 X Slope (%)	N/A
N/A	Ramp inside XWalk1?	N/A	N/A	Ramp inside XWalk2?	N/A

Road Slope (%)	N/A	N/A	Clear Space?	N/A
	Road X Slope (%)	N/A	N/A	Clear Space to XWalk (in)	N/A
N/A	Any Obstructions?	N/A	N/A	Storm Grate/Utility Hazard?	N/A
	Obstruction Type			Storm Grate/Utility Type	
		N/A			N/A
			Yes	Surface Condition? (G/P)	Good
			N/A	Curb Slope (%)	12.5

**Remove & Replace Entire Ramp.**

**R304.3.2, R304.5.3**
