## Access Compliance Report Public Rights-of-Way (Curb Ramps)

<b></b>		,					
Intersection ID: 10035178 Main Street: QUAIL_HOLLOW_RD Cross					N/A	Location:	SW		
ADA ID: 3D3B261737AC Ramp Type: PerpDiag Initial					ail: Pass Overall	o Severity Score:	17.5		
Codes/Mitigation Info/Possible Solution				Field Measurements/Component Compliance					
		Possible Solutions:		Compliance Description		Data Compliance Description		liance Description	Data
WE ELLIT		Remove & Replace Curb Ramp W	Vith	N/A	Ramp Length (in)	95.0	Yes	Ramp Slope (%)	5.4
		Two New Directional Ramps or Equivalent. Remove & Replace Gutter.		Yes	Ramp Width (in)	48.0	Yes	Ramp XSlope (%)	2.0
The second second				N/A	Flare Type LT	Sloped	N/A	Flare Type RT	N/A
Ten of a				N/A	Flare Slope LT (%)	2.7	N/A	Flare Slope RT (%)	5.9
				N/A	Flare Traversable LT?	Yes	N/A	Flare Traversable RT?	No
				No	Landing Length (in)	N/A	Yes	DWS Provided?	Yes
		Surveyor Notes:		No	Landing Width (in)	N/A	Yes	DWS Contrast?	Yes

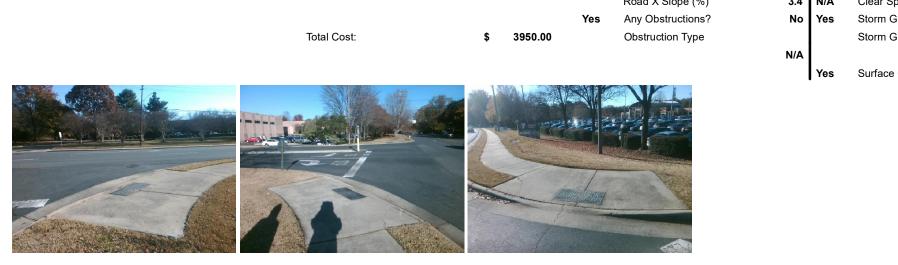
N/A		No	Landing Slope (%)	N/A	Yes	DWS Length (in)	24.0
				No	Landing X Slope (%)	N/A	No	DWS Full Width?	No
				N/A	Landing Curb? (Y/N)	No	No	DWS Offset (in)	6.0
				N/A	Shared Landing?	N/A			
		PROW/ADA:		Yes	Gutter Ponding?	No	No	Gutter Slope (%)	5.3
		R304.2.1, R304.2.2-Perp, R304.3.2	2-	Yes	Gutter Lip Ht (in)	0.0	No	Gutter X Slope (%)	2.6
		Para, R304.5.3, R305.1.4, R305.2,		N/A	Painted X Walk1?	No	N/A	Painted X Walk2?	No
		R304.5.4			X Walk 1 Direction	To NE		X Walk 2 Direction	To NW
				N/A	X Walk 1 Width (in)	N/A	N/A	X Walk 2 Width (in)	N/A
Street 1 Name	QUAIL HOLLOW RD				X Walk 1 Slope (%)	0.2		X Walk 2 Slope (%)	4.6
Stop Condition-Street 2	None				X Walk 1 X Slope (%)	4.1		X Walk 2 X Slope (%)	1.3
Street 2 Name	ENTRANCE			N/A	Ramp inside XWalk1?	N/A	N/A	Ramp inside XWalk2?	N/A
Stop Condition-Street 1	StopSign				Road Slope (%)	1.6	N/A	Clear Space?	Yes
					Road X Slope (%)	3.4	N/A	Clear Space to XWalk (in)	N/A

Yes	Any Obstructions?	No	Yes	Storm Grate/Utility Hazard?	No
		Total Cost: \$ 3	950.00		Obstruction Type			Storm Grate/Utility Type	
						N/A			N/A
1
