Access Compliance Report

Public Rights-of-Way

(Curb Ramps)

Intersection ID: 27680	Main Street: LANCASTER_HY	Cross Street: BALLANTYNE_COMMONS_PY	Location: SE
ADA ID: 3D456AACD80A	Ramp Type: Perp	Initial Pass/Fail: Fail	Overall Compliance: No
Severity Score: 21.25			
Codes/Mitigation Info/Possible Solution		Field Measurements/Component Compliance

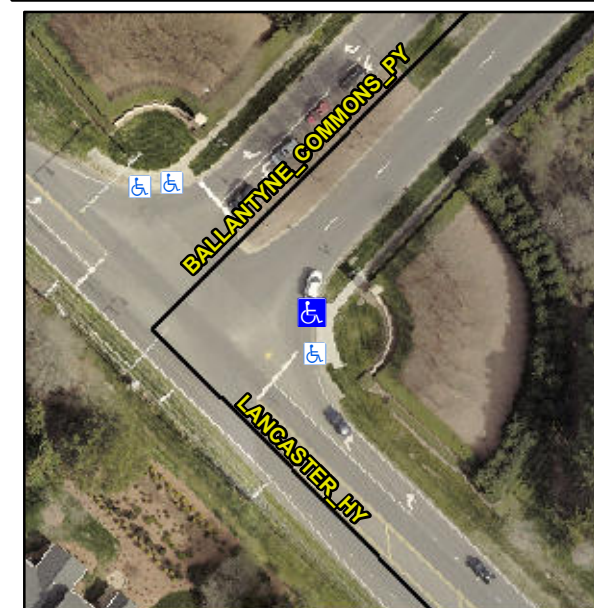
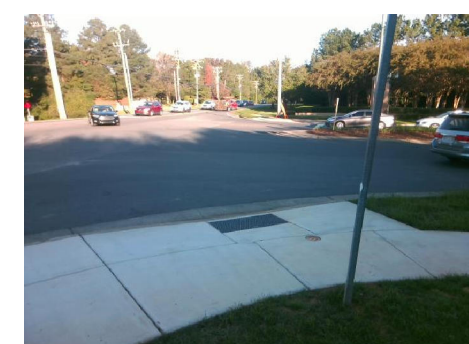
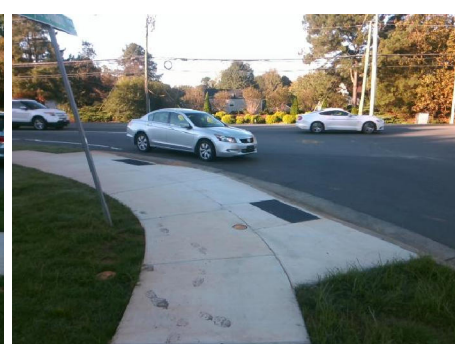
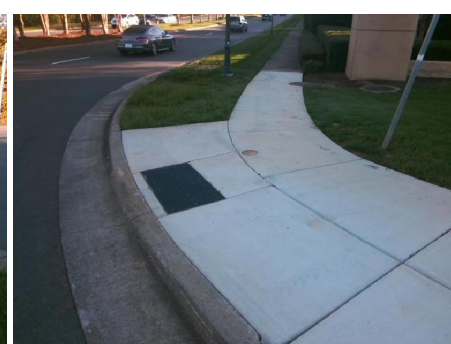
Not Found, R304.5.1, R304.5.3

Compliance	Description	Data	Compliance	Description	Data
N/A	Ramp Length (in)	51.0	Yes	Ramp Slope (%)	5.3
No	Ramp Width (in)	47.0	No	Ramp XSlope (%)	5.5
N/A	Flare Type LT	N/A	N/A	Flare Type RT	N/A
N/A	Flare Slope LT (%)	N/A	N/A	Flare Slope RT (%)	N/A
N/A	Flare Traversable LT?	N/A	N/A	Flare Traversable RT?	N/A
N/A	Landing Length (in)	N/A	N/A	DWS Provided?	N/A
N/A	Landing Width (in)	N/A	N/A	DWS Contrast?	N/A
N/A	Landing Slope (%)	N/A	N/A	DWS Length (in)	N/A
N/A	Landing X Slope (%)	N/A	N/A	DWS Full Width?	N/A
N/A	Landing Curb? (Y/N)	N/A	N/A	DWS Offset (in)	N/A
N/A	Shared Landing?	N/A			
N/A	Gutter Ponding?	N/A	N/A	Gutter Slope (%)	N/A
N/A	Gutter Lip Ht (in)	N/A	N/A	Gutter X Slope (%)	N/A
N/A	Painted X Walk1?	No	N/A	Painted X Walk2?	N/A
	X Walk 1 Direction	To NW		X Walk 2 Direction	N/A
N/A	X Walk 1 Width (in)	N/A	N/A	X Walk 2 Width (in)	N/A
	X Walk 1 Slope (%)	0.8		X Walk 2 Slope (%)	N/A
	X Walk 1 X Slope (%)	3.9		X Walk 2 X Slope (%)	N/A

N/A	Ramp inside XWalk1?	N/A	N/A	Ramp inside XWalk2?	N/A
	Road Slope (%)	N/A	N/A	Clear Space?	N/A
	Road X Slope (%)	N/A	N/A	Clear Space to XWalk (in)	N/A
N/A	Any Obstructions?	N/A	N/A	Storm Grate/Utility Hazard?	N/A
	Obstruction Type			Storm Grate/Utility Type	
		N/A			N/A
		Yes		Surface Condition? (G/P)	Good

Remove & Replace Entire Ramp.

Total Cost: \$ 1850.00
