# Access Compliance Report

## Public Rights-of-Way

### (Curb Ramps)

Intersection ID: 2910	Main Street: RIDGEFIELD_DR	Cross Street: SWANSTON_DR	Location: SE
ADA ID: 3D49E6D5BFD7	Ramp Type: PerpDiag	Initial Pass/Fail: Fail	Overall Compliance: No
		Severity Score: 42.5

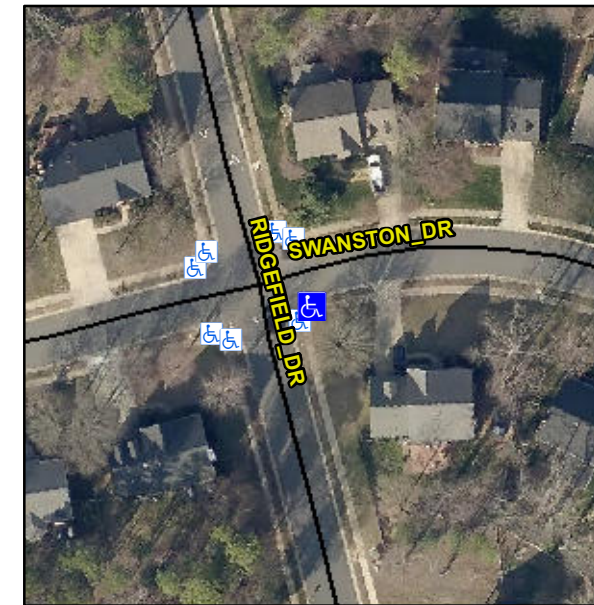
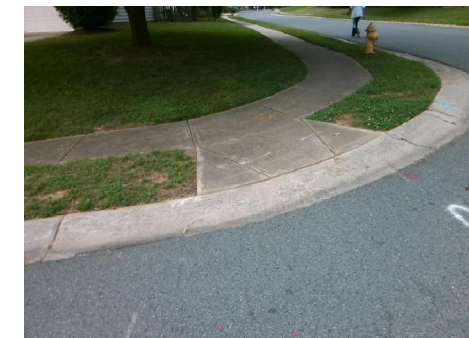
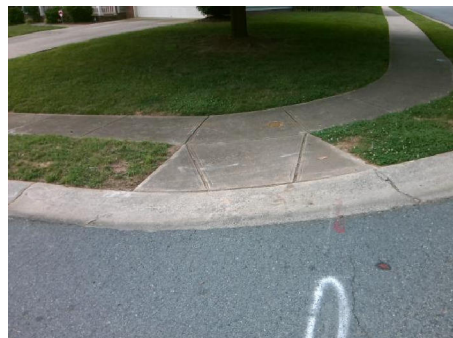
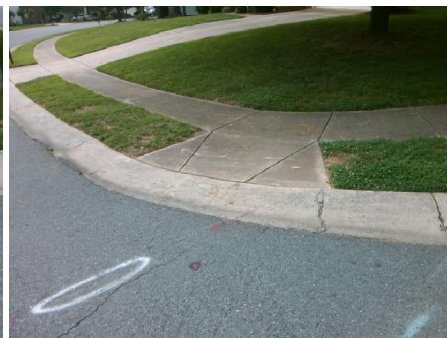
**Not Found, R304.5.1, R304.5.3**

Compliance	Description	Data	Compliance	Description	Data
N/A	Ramp Length (in)	46.0	Yes	Ramp Slope (%)	6.0
No	Ramp Width (in)	34.0	No	Ramp XSlope (%)	9.6
N/A	Flare Type LT	N/A	N/A	Flare Type RT	N/A
N/A	Flare Slope LT (%)	N/A	N/A	Flare Slope RT (%)	N/A
N/A	Flare Traversable LT?	N/A	N/A	Flare Traversable RT?	N/A
N/A	Landing Length (in)	N/A	N/A	DWS Provided?	N/A
N/A	Landing Width (in)	N/A	N/A	DWS Contrast?	N/A
N/A	Landing Slope (%)	N/A	N/A	DWS Length (in)	N/A
N/A	Landing X Slope (%)	N/A	N/A	DWS Full Width?	N/A
N/A	Landing Curb? (Y/N)	N/A	N/A	DWS Offset (in)	N/A
N/A	Shared Landing?	N/A			
N/A	Gutter Ponding?	N/A	N/A	Gutter Slope (%)	N/A
N/A	Gutter Lip Ht (in)	N/A	N/A	Gutter X Slope (%)	N/A
N/A	Painted X Walk1?	No	N/A	Painted X Walk2?	No
	X Walk 1 Direction	To N		X Walk 2 Direction	To W
N/A	X Walk 1 Width (in)	N/A	N/A	X Walk 2 Width (in)	N/A
	X Walk 1 Slope (%)	1.8		X Walk 2 Slope (%)	4.9
	X Walk 1 X Slope (%)	5.6		X Walk 2 X Slope (%)	0.3

N/A	Ramp inside XWalk1?	N/A	N/A	Ramp inside XWalk2?	N/A
	Road Slope (%)	6.3	N/A	Clear Space?	N/A
	Road X Slope (%)	4.9	N/A	Clear Space to XWalk (in)	N/A
N/A	Any Obstructions?	N/A	N/A	Storm Grate/Utility Hazard?	N/A
	Obstruction Type			Storm Grate/Utility Type	
		N/A			N/A
			Yes	Surface Condition? (G/P)	Good

**Remove & Replace Curb Ramp With Two New Directional Ramps or Equivalent.**
