# Access Compliance Report

## Public Rights-of-Way

### (Curb Ramps)

Intersection ID: 46697	Main Street: GOLDFIELDS_DR	Cross Street: COFFEEBERRY_LN	Location: NE
ADA ID: 3D4EDE59AFA7	Ramp Type: PerpDiag	Initial Pass/Fail: Fail	Overall Compliance: No
Severity Score: 22.5			
Codes/Mitigation Info/Possible Solution		Field Measurements/Component Compliance

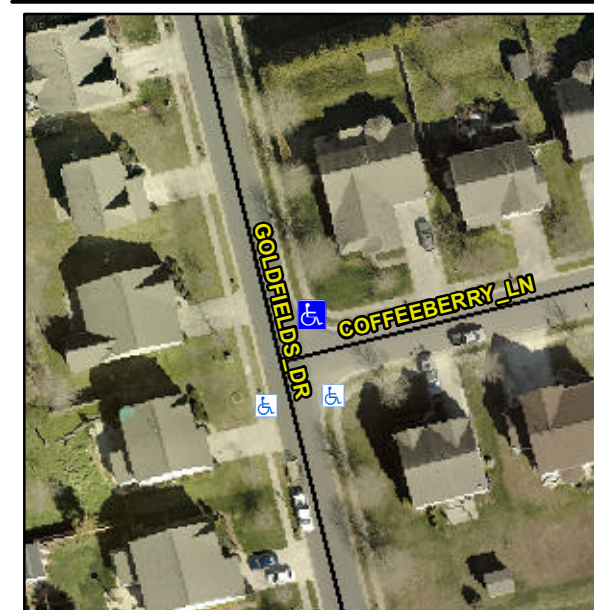
**Not Found, R304.5.1, R304.2.2, R304.5.3**

Compliance	Description	Data	Compliance	Description	Data
N/A	Ramp Length (in)	46.0	No	Ramp Slope (%)	8.4
No	Ramp Width (in)	47.0	No	Ramp XSlope (%)	2.6
N/A	Flare Type LT	N/A	N/A	Flare Type RT	N/A
N/A	Flare Slope LT (%)	N/A	N/A	Flare Slope RT (%)	N/A
N/A	Flare Traversable LT?	N/A	N/A	Flare Traversable RT?	N/A
N/A	Landing Length (in)	N/A	N/A	DWS Provided?	N/A
N/A	Landing Width (in)	N/A	N/A	DWS Contrast?	N/A
N/A	Landing Slope (%)	N/A	N/A	DWS Length (in)	N/A
N/A	Landing X Slope (%)	N/A	N/A	DWS Full Width?	N/A
N/A	Landing Curb? (Y/N)	N/A	N/A	DWS Offset (in)	N/A
N/A	Shared Landing?	N/A			
N/A	Gutter Ponding?	N/A	N/A	Gutter Slope (%)	N/A
N/A	Gutter Lip Ht (in)	N/A	N/A	Gutter X Slope (%)	N/A
N/A	Painted X Walk1?	No	N/A	Painted X Walk2?	No
	X Walk 1 Direction	To W		X Walk 2 Direction	To S
N/A	X Walk 1 Width (in)	N/A	N/A	X Walk 2 Width (in)	N/A
	X Walk 1 Slope (%)	0.2		X Walk 2 Slope (%)	3.3
	X Walk 1 X Slope (%)	2.9		X Walk 2 X Slope (%)	0.8

N/A	Ramp inside XWalk1?	N/A	N/A	Ramp inside XWalk2?	N/A
	Road Slope (%)	2.3	N/A	Clear Space?	N/A
	Road X Slope (%)	2.5	N/A	Clear Space to XWalk (in)	N/A
N/A	Any Obstructions?	N/A	N/A	Storm Grate/Utility Hazard?	N/A
	Obstruction Type			Storm Grate/Utility Type	
		N/A			N/A
			Yes	Surface Condition? (G/P)	Good

**Remove & Replace Curb Ramp With Two New Directional Ramps or Equivalent.**
