# Access Compliance Report

## Public Rights-of-Way

### (Curb Ramps)

Intersection ID: 7826	Main Street: BROOKSHIRE_BV	Cross Street: DAKOTA_ST	Location:	N
ADA ID: 3D51F086314C	Ramp Type: Perp	Initial Pass/Fail: Fail	Overall Compliance: No	Severity Score: 22.5
Codes/Mitigation Info/Possible Solution		Field Measurements/Component Compliance

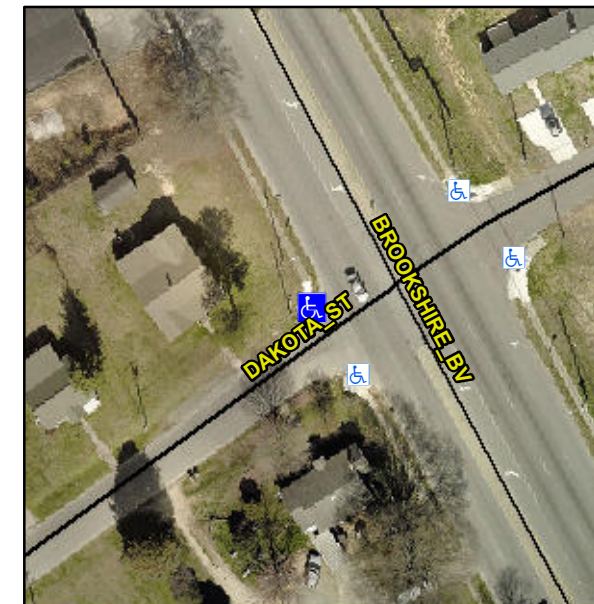
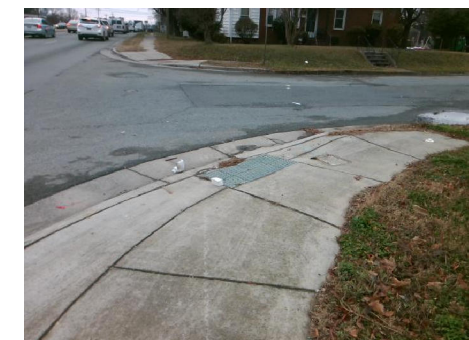
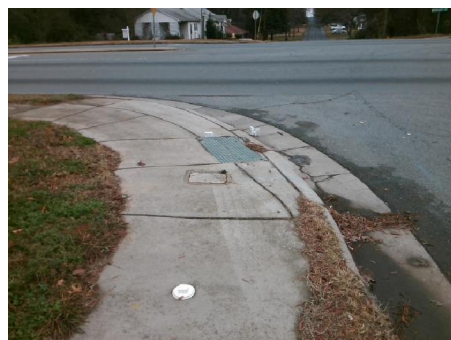
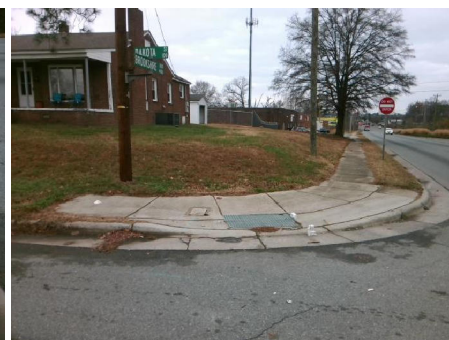
**Not Found, R304.5.1, R304.2.2, R304.5.3**

Compliance	Description	Data	Compliance	Description	Data
N/A	Ramp Length (in)	75.0	No	Ramp Slope (%)	8.7
No	Ramp Width (in)	46.0	No	Ramp XSlope (%)	2.6
N/A	Flare Type LT	N/A	N/A	Flare Type RT	N/A
N/A	Flare Slope LT (%)	N/A	N/A	Flare Slope RT (%)	N/A
N/A	Flare Traversable LT?	N/A	N/A	Flare Traversable RT?	N/A
N/A	Landing Length (in)	N/A	N/A	DWS Provided?	N/A
N/A	Landing Width (in)	N/A	N/A	DWS Contrast?	N/A
N/A	Landing Slope (%)	N/A	N/A	DWS Length (in)	N/A
N/A	Landing X Slope (%)	N/A	N/A	DWS Full Width?	N/A
N/A	Landing Curb? (Y/N)	N/A	N/A	DWS Offset (in)	N/A
N/A	Shared Landing?	N/A			
N/A	Gutter Ponding?	N/A	N/A	Gutter Slope (%)	N/A
N/A	Gutter Lip Ht (in)	N/A	N/A	Gutter X Slope (%)	N/A
N/A	Painted X Walk1?	No	N/A	Painted X Walk2?	N/A
	X Walk 1 Direction	To SE		X Walk 2 Direction	N/A
N/A	X Walk 1 Width (in)	N/A	N/A	X Walk 2 Width (in)	N/A
	X Walk 1 Slope (%)	4.3		X Walk 2 Slope (%)	N/A
	X Walk 1 X Slope (%)	2.7		X Walk 2 X Slope (%)	N/A

N/A	Ramp inside XWalk1?	N/A	N/A	Ramp inside XWalk2?	N/A
	Road Slope (%)	N/A	N/A	Clear Space?	N/A
	Road X Slope (%)	N/A	N/A	Clear Space to XWalk (in)	N/A
N/A	Any Obstructions?	N/A	N/A	Storm Grate/Utility Hazard?	N/A
	Obstruction Type			Storm Grate/Utility Type	
		N/A			N/A
			Yes	Surface Condition? (G/P)	Good

**Remove & Replace Entire Ramp.**
