Access Compliance Report

Public Rights-of-Way

(Curb Ramps)

Intersection ID: 47611	Main Street: WYALONG_DR	Cross Street: MINTWORTH_AV	Location: SE
ADA ID: 3D534E6C38FC	Ramp Type: Perp	Initial Pass/Fail: Fail	Overall Compliance: No
		Severity Score: 12.5

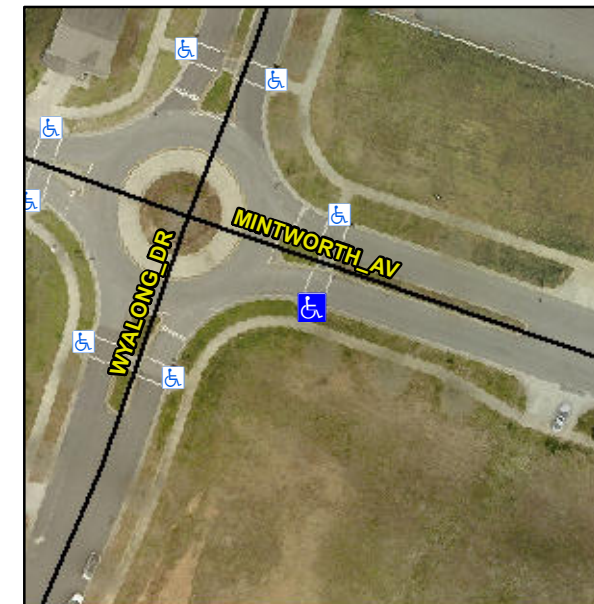
R304.2.2

Compliance	Description	Data	Compliance	Description	Data
N/A	Ramp Length (in)	96.0	No	Ramp Slope (%)	9.3
Yes	Ramp Width (in)	69.0	Yes	Ramp XSlope (%)	1.6
N/A	Flare Type LT	N/A	N/A	Flare Type RT	N/A
N/A	Flare Slope LT (%)	N/A	N/A	Flare Slope RT (%)	N/A
N/A	Flare Traversable LT?	N/A	N/A	Flare Traversable RT?	N/A
N/A	Landing Length (in)	N/A	N/A	DWS Provided?	N/A
N/A	Landing Width (in)	N/A	N/A	DWS Contrast?	N/A
N/A	Landing Slope (%)	N/A	N/A	DWS Length (in)	N/A
N/A	Landing X Slope (%)	N/A	N/A	DWS Full Width?	N/A
N/A	Landing Curb? (Y/N)	N/A	N/A	DWS Offset (in)	N/A
N/A	Shared Landing?	N/A			
N/A	Gutter Ponding?	N/A	N/A	Gutter Slope (%)	N/A
N/A	Gutter Lip Ht (in)	N/A	N/A	Gutter X Slope (%)	N/A
N/A	Painted X Walk1?	Yes	N/A	Painted X Walk2?	N/A
	X Walk 1 Direction	To NE		X Walk 2 Direction	N/A
N/A	X Walk 1 Width (in)	119.0	N/A	X Walk 2 Width (in)	N/A
	X Walk 1 Slope (%)	4.1		X Walk 2 Slope (%)	N/A
	X Walk 1 X Slope (%)	0.8		X Walk 2 X Slope (%)	N/A

Remove & Replace Entire Ramp.

\$ 1850.00
