# Access Compliance Report

## Public Rights-of-Way

### (Curb Ramps)

Intersection ID: 50584	Main Street: GREAT_LAUREL_RD	Cross Street: GRAND_FIR_RD	Location: NW
ADA ID: 3D6122E7888D	Ramp Type: Perp	Initial Pass/Fail: Fail	Overall Compliance: No
Severity Score: 10			
Codes/Mitigation Info/Possible Solution		Field Measurements/Component Compliance

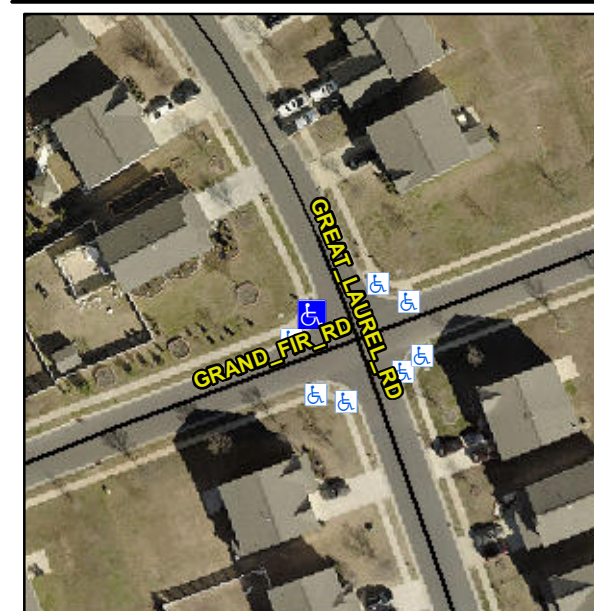
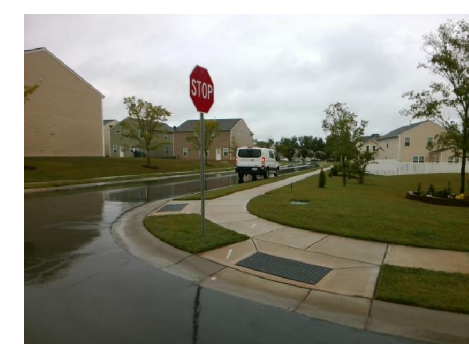
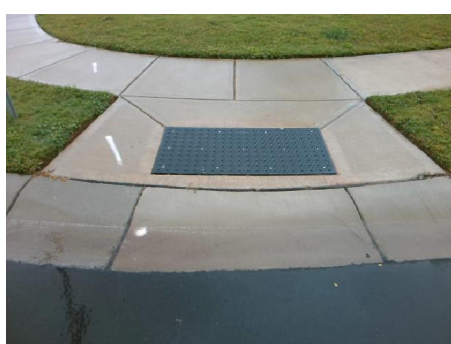
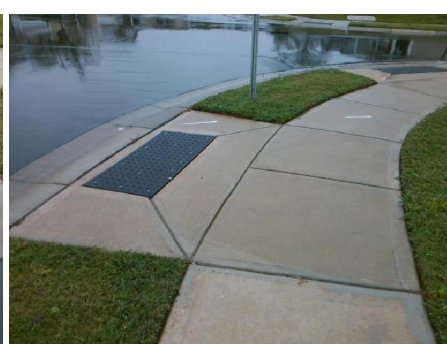
**Not Found, R304.5.1, R304.5.3**

Compliance	Description	Data	Compliance	Description	Data
N/A	Ramp Length (in)	50.5	Yes	Ramp Slope (%)	6.4
No	Ramp Width (in)	47.5	No	Ramp XSlope (%)	3.7
N/A	Flare Type LT	N/A	N/A	Flare Type RT	N/A
N/A	Flare Slope LT (%)	N/A	N/A	Flare Slope RT (%)	N/A
N/A	Flare Traversable LT?	N/A	N/A	Flare Traversable RT?	N/A
N/A	Landing Length (in)	N/A	N/A	DWS Provided?	N/A
N/A	Landing Width (in)	N/A	N/A	DWS Contrast?	N/A
N/A	Landing Slope (%)	N/A	N/A	DWS Length (in)	N/A
N/A	Landing X Slope (%)	N/A	N/A	DWS Full Width?	N/A
N/A	Landing Curb? (Y/N)	N/A	N/A	DWS Offset (in)	N/A
N/A	Shared Landing?	N/A			
N/A	Gutter Ponding?	N/A	N/A	Gutter Slope (%)	N/A
N/A	Gutter Lip Ht (in)	N/A	N/A	Gutter X Slope (%)	N/A
N/A	Painted X Walk1?	No	N/A	Painted X Walk2?	N/A
	X Walk 1 Direction	To E		X Walk 2 Direction	N/A
N/A	X Walk 1 Width (in)	N/A	N/A	X Walk 2 Width (in)	N/A
	X Walk 1 Slope (%)	3.7		X Walk 2 Slope (%)	N/A
	X Walk 1 X Slope (%)	3.9		X Walk 2 X Slope (%)	N/A

N/A	Ramp inside XWalk1?	N/A	N/A	Ramp inside XWalk2?	N/A
	Road Slope (%)	N/A	N/A	Clear Space?	N/A
	Road X Slope (%)	N/A	N/A	Clear Space to XWalk (in)	N/A
N/A	Any Obstructions?	N/A	N/A	Storm Grate/Utility Hazard?	N/A
	Obstruction Type			Storm Grate/Utility Type	
		N/A			N/A
		Yes		Surface Condition? (G/P)	Good

**Remove & Replace Entire Ramp.**
