Access Compliance Report Public Rights-of-Way (Curb Ramps)

Intersection ID: 44166	Main Street: COCHRANE_DR			reet:	PAWPAW_LN	Location:	NE		
ADA ID: 3D6342C1F201	Ramp Ty	Ramp Type: PerpDiag			ail: Fail Overall C	o Severity Score:	21.25		
Codes/Mitigation Info/Possible Solution				Field Measurements/Component Compliance					
		Possible Solutions:	Compliance Description				Data Compliance Description		
		Remove & Replace Curb Ramp	ith l	N/A	Ramp Length (in)	81.0	No	Ramp Slope (%)	9.9
		Two New Directional Ramps or		No	Ramp Width (in)	45.0		Ramp XSlope (%)	0.5
		Equivalent.		N/A	Flare Type LT	N/A	N/A	Flare Type RT	N/A
				N/A	Flare Slope LT (%)	N/A	N/A	Flare Slope RT (%)	N/A
				N/A	Flare Traversable LT?	N/A	N/A	Flare Traversable RT?	N/A
1 小、唐堂				N/A	Landing Length (in)	N/A	N/A	DWS Provided?	N/A
		Surveyor Notes:		N/A	Landing Width (in)	N/A	N/A	DWS Contrast?	N/A
		N/A		N/A	Landing Slope (%)	N/A	N/A	DWS Length (in)	N/A
5 OLDANIE		N/A		N/A	Landing X Slope (%)	N/A	N/A	DWS Full Width?	N/A

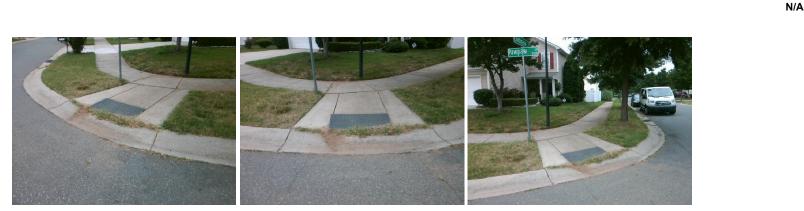
Con the Good				N/A	Landing Curb? (Y/N)	N/A	N/A	DWS Offset (in)	N/A
6. 33				N/A	Shared Landing?	N/A		2110 01101 (111)	
	1 11-1-1-	PROW/ADA:		N/A	Gutter Ponding?	N/A	N/A	Gutter Slope (%)	N/A
		Not Found, R304.5.1, R304.2.2		N/A	Gutter Lip Ht (in)	N/A		Gutter X Slope (%)	N/A
Not Found, R304.5.1, R304.2.2				N/A	Painted X Walk1?	No	N/A	Painted X Walk2?	No
				WA	X Walk 1 Direction	To W		X Walk 2 Direction	To S
				N/A	X Walk 1 Width (in)	N/A	N/A	X Walk 2 Width (in)	N/A
Street 1 Name	PAWPAW LN		•	1/1	X Walk 1 Slope (%)	0.4		X Walk 2 Slope (%)	0.1
Stop Condition-Street 2	StopSign				X Walk 1 X Slope (%)	0.4		X Walk 2 X Slope (%)	0.1
Street 2 Name	COCHRANE DR			N/A	Ramp inside XWalk1?	0.8 N/A	N/A	Ramp inside XWalk2?	0.4 N/A
Stop Condition-Street 1	None		•	N/A	Road Slope (%)	0.4	N/A	Clear Space?	N/A N/A
Stop Condition-Street 1	None					-			
					Road X Slope (%)	0.4	N/A	Clear Space to XWalk (in)	N/A
		Table Cards		N/A	Any Obstructions?	N/A	N/A	Storm Grate/Utility Hazard?	N/A
