# Access Compliance Report

## Public Rights-of-Way

### (Curb Ramps)

Intersection ID: 18784	Main Street: SEACROFT_RD	Cross Street: SENECA_PL	Location: SE
ADA ID: 3D6836CCB00E	Ramp Type: PerpDiag	Initial Pass/Fail: Fail	Overall Compliance: No
		Severity Score: 12.5

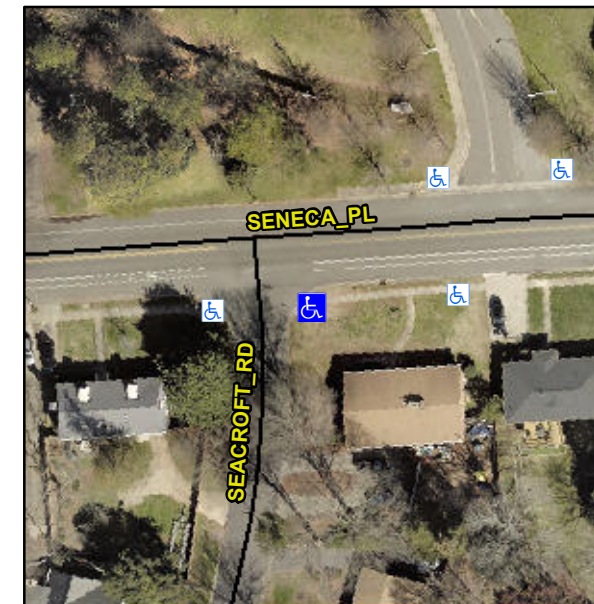
**Not Found, R304.5.3**

Compliance	Description	Data	Compliance	Description	Data
N/A	Ramp Length (in)	80.0	Yes	Ramp Slope (%)	5.2
Yes	Ramp Width (in)	48.0	No	Ramp XSlope (%)	5.1
N/A	Flare Type LT	N/A	N/A	Flare Type RT	N/A
N/A	Flare Slope LT (%)	N/A	N/A	Flare Slope RT (%)	N/A
N/A	Flare Traversable LT?	N/A	N/A	Flare Traversable RT?	N/A
N/A	Landing Length (in)	N/A	N/A	DWS Provided?	N/A
N/A	Landing Width (in)	N/A	N/A	DWS Contrast?	N/A
N/A	Landing Slope (%)	N/A	N/A	DWS Length (in)	N/A
N/A	Landing X Slope (%)	N/A	N/A	DWS Full Width?	N/A
N/A	Landing Curb? (Y/N)	N/A	N/A	DWS Offset (in)	N/A
N/A	Shared Landing?	N/A			
N/A	Gutter Ponding?	N/A	N/A	Gutter Slope (%)	N/A
N/A	Gutter Lip Ht (in)	N/A	N/A	Gutter X Slope (%)	N/A
N/A	Painted X Walk1?	No	N/A	Painted X Walk2?	No
	X Walk 1 Direction	To N		X Walk 2 Direction	To W
N/A	X Walk 1 Width (in)	N/A	N/A	X Walk 2 Width (in)	N/A
	X Walk 1 Slope (%)	6.0		X Walk 2 Slope (%)	0.9
	X Walk 1 X Slope (%)	0.6		X Walk 2 X Slope (%)	4.5

N/A	Ramp inside XWalk1?	N/A	N/A	Ramp inside XWalk2?	N/A
	Road Slope (%)	3.9	N/A	Clear Space?	N/A
	Road X Slope (%)	4.3	N/A	Clear Space to XWalk (in)	N/A
N/A	Any Obstructions?	N/A	N/A	Storm Grate/Utility Hazard?	N/A
	Obstruction Type			Storm Grate/Utility Type	
		N/A			N/A
			Yes	Surface Condition? (G/P)	Good

Possible Solutions:

**Remove & Replace Curb Ramp With Two New Directional Ramps or Equivalent.**

Total Cost: \$ 3200.00
