# Access Compliance Report

## Public Rights-of-Way

### (Curb Ramps)

Intersection ID: 13714	Main Street: HANOVER_ST	Cross Street: MCCLINTOCK_RD	Location: SW
ADA ID: 3D6C0813E24B	Ramp Type: Perp	Initial Pass/Fail: Fail	Overall Compliance: No
		Severity Score: 21.25

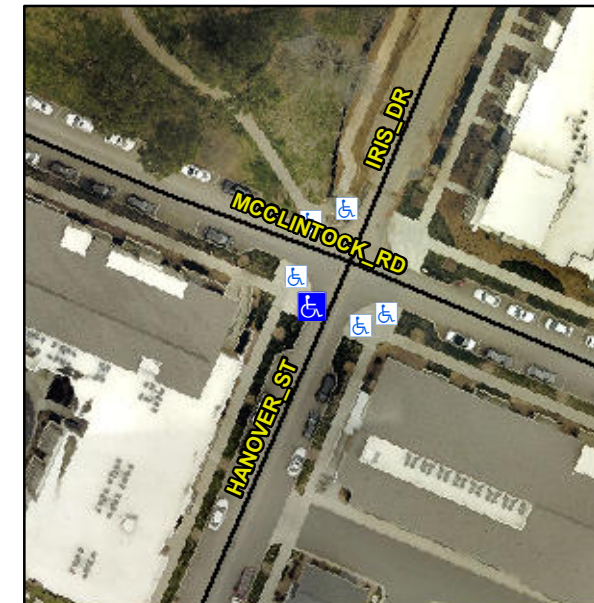
**Not Found, R304.5.1, R304.2.2**

Compliance	Description	Data	Compliance	Description	Data
N/A	Ramp Length (in)	88.0	No	Ramp Slope (%)	9.4
No	Ramp Width (in)	46.0	Yes	Ramp XSlope (%)	0.1
N/A	Flare Type LT	N/A	N/A	Flare Type RT	N/A
N/A	Flare Slope LT (%)	N/A	N/A	Flare Slope RT (%)	N/A
N/A	Flare Traversable LT?	N/A	N/A	Flare Traversable RT?	N/A
N/A	Landing Length (in)	N/A	N/A	DWS Provided?	N/A
N/A	Landing Width (in)	N/A	N/A	DWS Contrast?	N/A
N/A	Landing Slope (%)	N/A	N/A	DWS Length (in)	N/A
N/A	Landing X Slope (%)	N/A	N/A	DWS Full Width?	N/A
N/A	Landing Curb? (Y/N)	N/A	N/A	DWS Offset (in)	N/A
N/A	Shared Landing?	N/A			
N/A	Gutter Ponding?	N/A	N/A	Gutter Slope (%)	N/A
N/A	Gutter Lip Ht (in)	N/A	N/A	Gutter X Slope (%)	N/A
N/A	Painted X Walk1?	No	N/A	Painted X Walk2?	N/A
	X Walk 1 Direction	To SE		X Walk 2 Direction	N/A
N/A	X Walk 1 Width (in)	N/A	N/A	X Walk 2 Width (in)	N/A
	X Walk 1 Slope (%)	0.9		X Walk 2 Slope (%)	N/A
	X Walk 1 X Slope (%)	2.7		X Walk 2 X Slope (%)	N/A

N/A	Ramp inside XWalk1?	N/A	N/A	Ramp inside XWalk2?	N/A
	Road Slope (%)	N/A	N/A	Clear Space?	N/A
	Road X Slope (%)	N/A	N/A	Clear Space to XWalk (in)	N/A
N/A	Any Obstructions?	N/A	N/A	Storm Grate/Utility Hazard?	N/A
	Obstruction Type			Storm Grate/Utility Type	
		N/A			N/A
			Yes	Surface Condition? (G/P)	Good

Possible Solutions:

**Remove & Replace Entire Ramp.**
