# Access Compliance Report

## Public Rights-of-Way

### (Curb Ramps)

Intersection ID: 31206	Main Street: WESTBURY_GLEN_CT	Cross Street: LARIMER_LN	Location: S
ADA ID: 3D6D500BDBC1	Ramp Type: PerpDiag	Initial Pass/Fail: Fail	Overall Compliance: No
Severity Score: 21.25			
Codes/Mitigation Info/Possible Solution		Field Measurements/Component Compliance

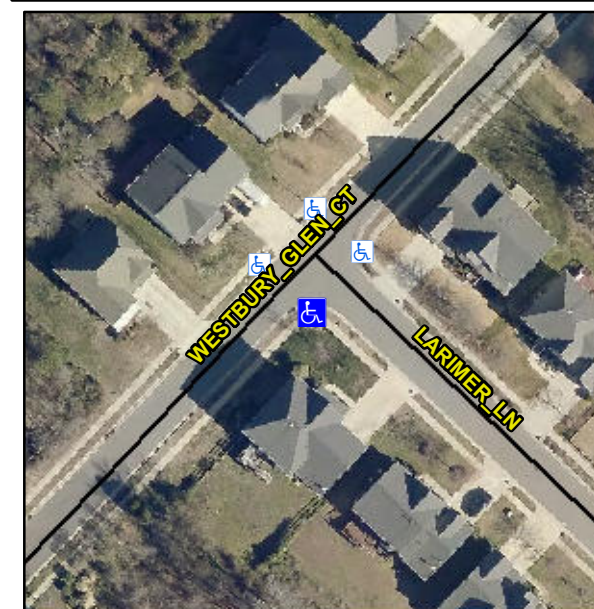
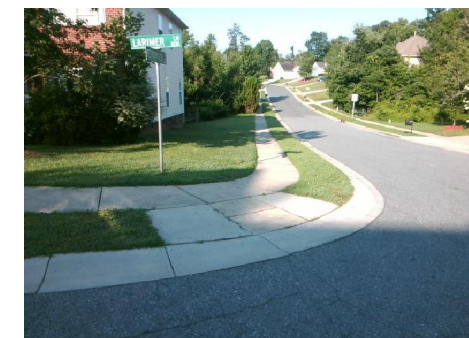
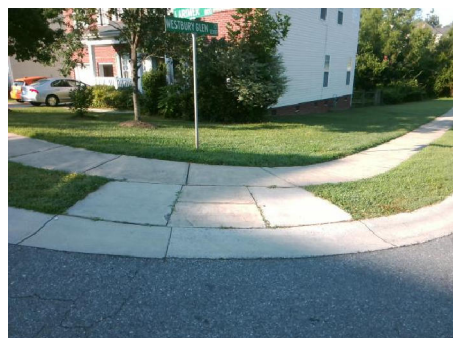
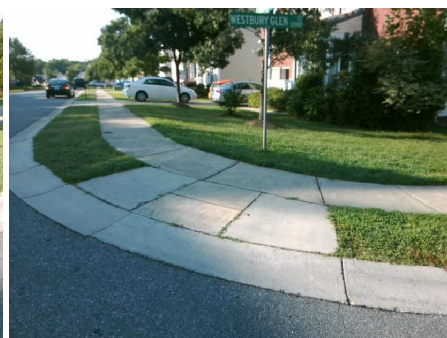
**Not Found, R304.5.1, R304.5.3**

Compliance	Description	Data	Compliance	Description	Data
N/A	Ramp Length (in)	51.0	Yes	Ramp Slope (%)	5.1
No	Ramp Width (in)	37.0	No	Ramp XSlope (%)	6.0
N/A	Flare Type LT	N/A	N/A	Flare Type RT	N/A
N/A	Flare Slope LT (%)	N/A	N/A	Flare Slope RT (%)	N/A
N/A	Flare Traversable LT?	N/A	N/A	Flare Traversable RT?	N/A
N/A	Landing Length (in)	N/A	N/A	DWS Provided?	N/A
N/A	Landing Width (in)	N/A	N/A	DWS Contrast?	N/A
N/A	Landing Slope (%)	N/A	N/A	DWS Length (in)	N/A
N/A	Landing X Slope (%)	N/A	N/A	DWS Full Width?	N/A
N/A	Landing Curb? (Y/N)	N/A	N/A	DWS Offset (in)	N/A
N/A	Shared Landing?	N/A			
N/A	Gutter Ponding?	N/A	N/A	Gutter Slope (%)	N/A
N/A	Gutter Lip Ht (in)	N/A	N/A	Gutter X Slope (%)	N/A
N/A	Painted X Walk1?	No	N/A	Painted X Walk2?	No
	X Walk 1 Direction	To NE		X Walk 2 Direction	To NW
N/A	X Walk 1 Width (in)	N/A	N/A	X Walk 2 Width (in)	N/A
	X Walk 1 Slope (%)	7.3		X Walk 2 Slope (%)	5.9
	X Walk 1 X Slope (%)	4.3		X Walk 2 X Slope (%)	1.0

N/A	Ramp inside XWalk1?	N/A	N/A	Ramp inside XWalk2?	N/A
	Road Slope (%)	8.3	N/A	Clear Space?	N/A
	Road X Slope (%)	4.2	N/A	Clear Space to XWalk (in)	N/A
N/A	Any Obstructions?	N/A	N/A	Storm Grate/Utility Hazard?	N/A
	Obstruction Type			Storm Grate/Utility Type	
		N/A			N/A
		Yes		Surface Condition? (G/P)	Good

**Remove & Replace Curb Ramp With Two New Directional Ramps or Equivalent.**
