Access Compliance Report

Public Rights-of-Way

(Curb Ramps)

| Intersection ID: 43988 | Main Street: N_HOSKINS_RD | Cross Street: TUCKERS_GLEN_LN | Location: N |

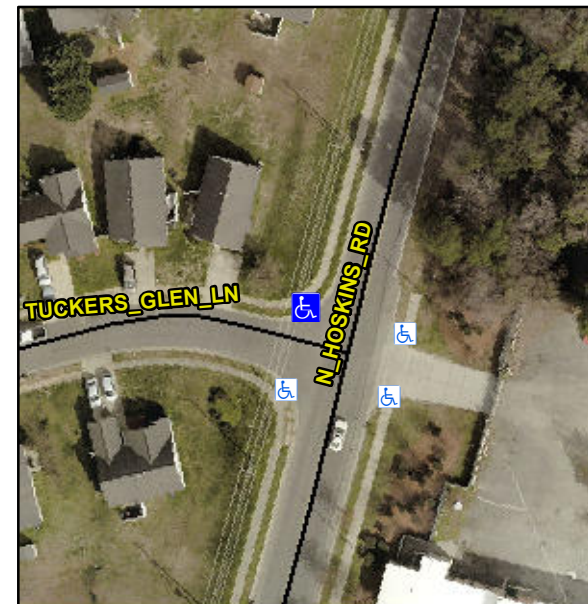
| ADA ID: 3D7B901BA027 | Ramp Type: PerpDiag | Initial Pass/Fail: Fail | Overall Compliance: No |

PROW/ADA:

R304.5.1, R304.2.2

| Compliance | Description | Data | Compliance | Description | Data |
|---|---|---|---|---|---|
| N/A | Ramp Length (in) | 84.5 | No | Ramp Slope (%) | 8.6 |
| No | Ramp Width (in) | 36.5 | Yes | Ramp XSlope (%) | 1.2 |

Possible Solutions:

Remove & Replace Curb Ramp With Two New Directional Ramps or Equivalent.

Total Cost: \$ **3200.00**
