Access Compliance Report

Public Rights-of-Way

(Curb Ramps)

Intersection ID: 27889	Main Street: ELROSE_PL	Cross Street: GANDER_DR	Location:	N
ADA ID: 3D7C6EA9A76D	Ramp Type: Perp	Initial Pass/Fail: Fail	Overall Compliance: No	Severity Score: 10
Codes/Mitigation Info/Possible Solution		Field Measurements/Component Compliance

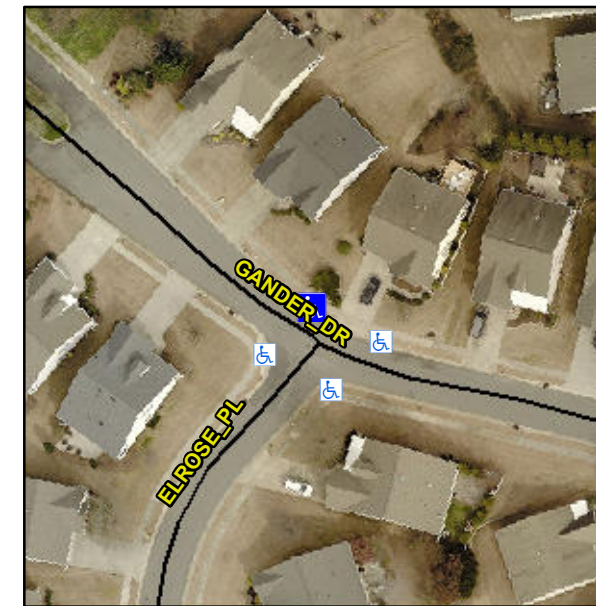
Not Found, R304.5.1, R304.5.3

Compliance	Description	Data	Compliance	Description	Data
N/A	Ramp Length (in)	45.0	Yes	Ramp Slope (%)	8.1
No	Ramp Width (in)	45.0	No	Ramp XSlope (%)	4.4
N/A	Flare Type LT	N/A	N/A	Flare Type RT	N/A
N/A	Flare Slope LT (%)	N/A	N/A	Flare Slope RT (%)	N/A
N/A	Flare Traversable LT?	N/A	N/A	Flare Traversable RT?	N/A
N/A	Landing Length (in)	N/A	N/A	DWS Provided?	N/A
N/A	Landing Width (in)	N/A	N/A	DWS Contrast?	N/A
N/A	Landing Slope (%)	N/A	N/A	DWS Length (in)	N/A
N/A	Landing X Slope (%)	N/A	N/A	DWS Full Width?	N/A
N/A	Landing Curb? (Y/N)	N/A	N/A	DWS Offset (in)	N/A
N/A	Shared Landing?	N/A			
N/A	Gutter Ponding?	N/A	N/A	Gutter Slope (%)	N/A
N/A	Gutter Lip Ht (in)	N/A	N/A	Gutter X Slope (%)	N/A
N/A	Painted X Walk1?	No	N/A	Painted X Walk2?	N/A
	X Walk 1 Direction	To SW		X Walk 2 Direction	N/A
N/A	X Walk 1 Width (in)	N/A	N/A	X Walk 2 Width (in)	N/A
	X Walk 1 Slope (%)	2.9		X Walk 2 Slope (%)	N/A
	X Walk 1 X Slope (%)	3.9		X Walk 2 X Slope (%)	N/A

N/A	Ramp inside XWalk1?	N/A	N/A	Ramp inside XWalk2?	N/A
	Road Slope (%)	N/A	N/A	Clear Space?	N/A
	Road X Slope (%)	N/A	N/A	Clear Space to XWalk (in)	N/A
N/A	Any Obstructions?	N/A	N/A	Storm Grate/Utility Hazard?	N/A
	Obstruction Type			Storm Grate/Utility Type	
		N/A			N/A
			Yes	Surface Condition? (G/P)	Good

Remove & Replace Entire Ramp.
