Access Compliance Report

Public Rights-of-Way

(Curb Ramps)

Intersection ID: 52783	Main Street: TAYLOR_RIDGE_LN	Cross Street: WITHER_STEELE_CT	Location: NE
ADA ID: 3D7FD86CB6B2	Ramp Type: Perp	Initial Pass/Fail: Fail	Overall Compliance: No
Severity Score: 22.5			
Codes/Mitigation Info/Possible Solution		Field Measurements/Component Compliance

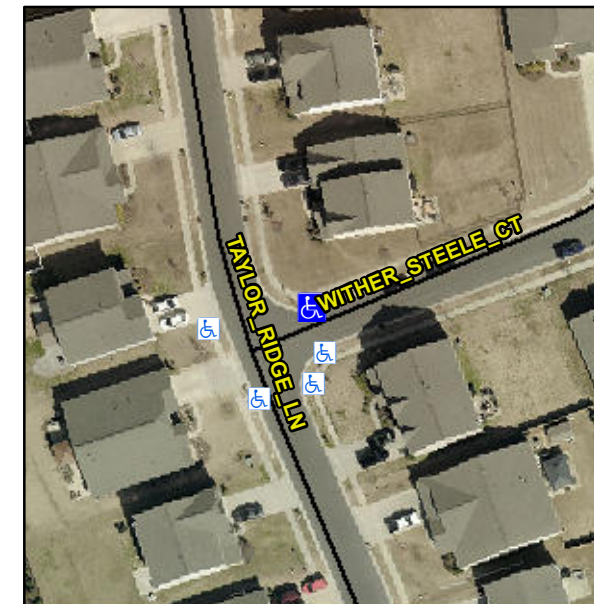
Not Found, R304.5.1, R304.2.2, R304.5.3

Compliance	Description	Data	Compliance	Description	Data
N/A	Ramp Length (in)	48.0	No	Ramp Slope (%)	9.0
No	Ramp Width (in)	47.0	No	Ramp XSlope (%)	2.6
N/A	Flare Type LT	N/A	N/A	Flare Type RT	N/A
N/A	Flare Slope LT (%)	N/A	N/A	Flare Slope RT (%)	N/A
N/A	Flare Traversable LT?	N/A	N/A	Flare Traversable RT?	N/A
N/A	Landing Length (in)	N/A	N/A	DWS Provided?	N/A
N/A	Landing Width (in)	N/A	N/A	DWS Contrast?	N/A
N/A	Landing Slope (%)	N/A	N/A	DWS Length (in)	N/A
N/A	Landing X Slope (%)	N/A	N/A	DWS Full Width?	N/A
N/A	Landing Curb? (Y/N)	N/A	N/A	DWS Offset (in)	N/A
N/A	Shared Landing?	N/A			
N/A	Gutter Ponding?	N/A	N/A	Gutter Slope (%)	N/A
N/A	Gutter Lip Ht (in)	N/A	N/A	Gutter X Slope (%)	N/A
N/A	Painted X Walk1?	No	N/A	Painted X Walk2?	N/A
	X Walk 1 Direction	To S		X Walk 2 Direction	N/A
N/A	X Walk 1 Width (in)	N/A	N/A	X Walk 2 Width (in)	N/A
	X Walk 1 Slope (%)	1.9		X Walk 2 Slope (%)	N/A
	X Walk 1 X Slope (%)	0.7		X Walk 2 X Slope (%)	N/A

Possible Solutions:

Remove & Replace Entire Ramp.
