# Access Compliance Report

## Public Rights-of-Way

### (Curb Ramps)

Intersection ID: 10021	Main Street: S_I-85_RA	Cross Street: TUCKASEEGEE_RD	Location: E
ADA ID: 3D805F8DBD2C	Ramp Type: Perp	Initial Pass/Fail: Fail	Overall Compliance: No
Severity Score: 22.5			
Codes/Mitigation Info/Possible Solution		Field Measurements/Component Compliance

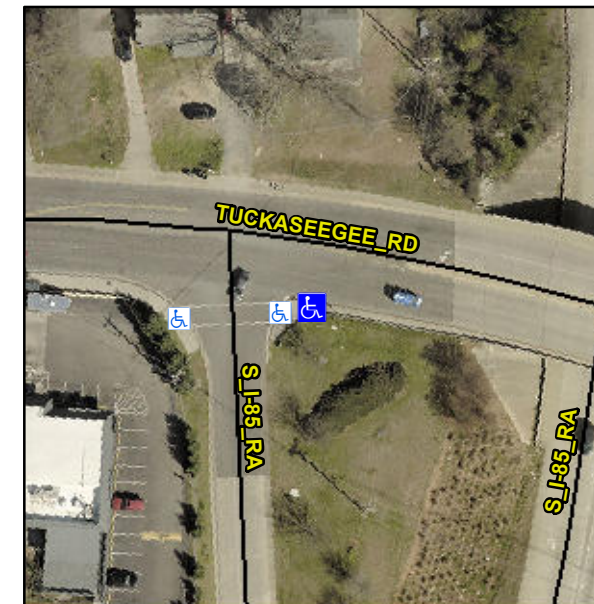
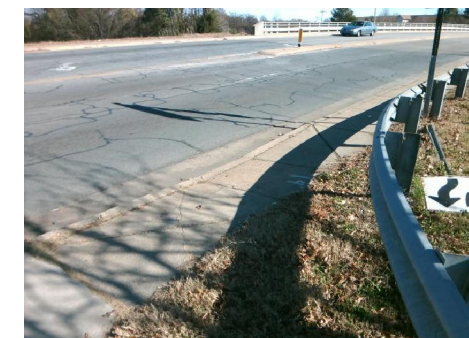
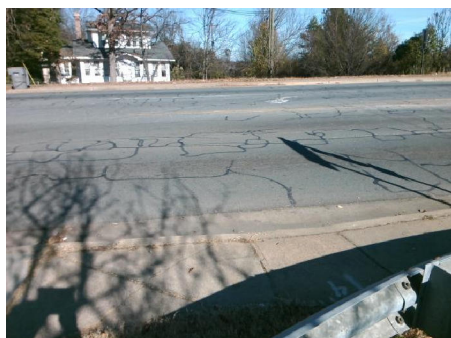
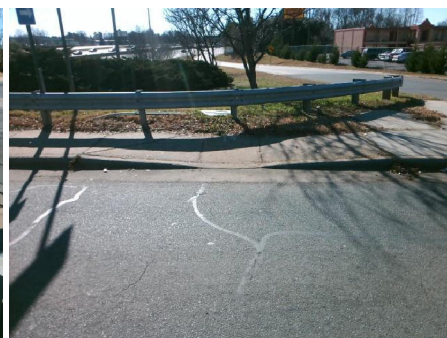
**Not Found, R304.5.1, R304.2.2, R304.5.3**

Compliance	Description	Data	Compliance	Description	Data
N/A	Ramp Length (in)	55.0	No	Ramp Slope (%)	11.1
No	Ramp Width (in)	39.0	No	Ramp XSlope (%)	2.7
N/A	Flare Type LT	N/A	N/A	Flare Type RT	N/A
N/A	Flare Slope LT (%)	N/A	N/A	Flare Slope RT (%)	N/A
N/A	Flare Traversable LT?	N/A	N/A	Flare Traversable RT?	N/A
N/A	Landing Length (in)	N/A	N/A	DWS Provided?	N/A
N/A	Landing Width (in)	N/A	N/A	DWS Contrast?	N/A
N/A	Landing Slope (%)	N/A	N/A	DWS Length (in)	N/A
N/A	Landing X Slope (%)	N/A	N/A	DWS Full Width?	N/A
N/A	Landing Curb? (Y/N)	N/A	N/A	DWS Offset (in)	N/A
N/A	Shared Landing?	N/A			
N/A	Gutter Ponding?	N/A	N/A	Gutter Slope (%)	N/A
N/A	Gutter Lip Ht (in)	N/A	N/A	Gutter X Slope (%)	N/A
N/A	Painted X Walk1?	No	N/A	Painted X Walk2?	N/A
	X Walk 1 Direction	To N		X Walk 2 Direction	N/A
N/A	X Walk 1 Width (in)	N/A	N/A	X Walk 2 Width (in)	N/A
	X Walk 1 Slope (%)	0.7		X Walk 2 Slope (%)	N/A
	X Walk 1 X Slope (%)	2.2		X Walk 2 X Slope (%)	N/A

N/A	Ramp inside XWalk1?	N/A	N/A	Ramp inside XWalk2?	N/A
	Road Slope (%)	N/A	N/A	Clear Space?	N/A
	Road X Slope (%)	N/A	N/A	Clear Space to XWalk (in)	N/A
N/A	Any Obstructions?	N/A	N/A	Storm Grate/Utility Hazard?	N/A
	Obstruction Type			Storm Grate/Utility Type	
		N/A			N/A
			Yes	Surface Condition? (G/P)	Good

**Remove & Replace Entire Ramp.**

Total Cost: \$ 1850.00
