## **Access Compliance Report Public Rights-of-Way** (Curb Ramps)

Intersection ID: 46028 Main Street: BEATTIES FORD RD **Cross Street: PAULINE LN** Location: SW Initial Pass/Fail: Fail **Overall Compliance: No Severity Score:** ADA ID: 3DBBE6253102 Ramp Type: Perp 37.5

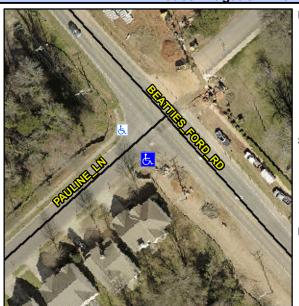
**PAULINE LN** Street 1 Name Stop Condition-Street 2 StopSign N/A Street 2 Name Stop Condition-Street 1 N/A Possible Solutions: Remove & Replace Entire Ramp. Surveyor Notes: N/A PROW/ADA: Not Found, R304.2.2, R304.5.3
