Access Compliance Report

Public Rights-of-Way

(Curb Ramps)

Intersection ID: 13916	Main Street: CLANTON_RD	Cross Street: WEST_BV	Location: SE
ADA ID: 3DC7E2C14FD1	Ramp Type: Perp	Initial Pass/Fail: Fail	Overall Compliance: No
Severity Score: 26.25			
Codes/Mitigation Info/Possible Solution		Field Measurements/Component Compliance

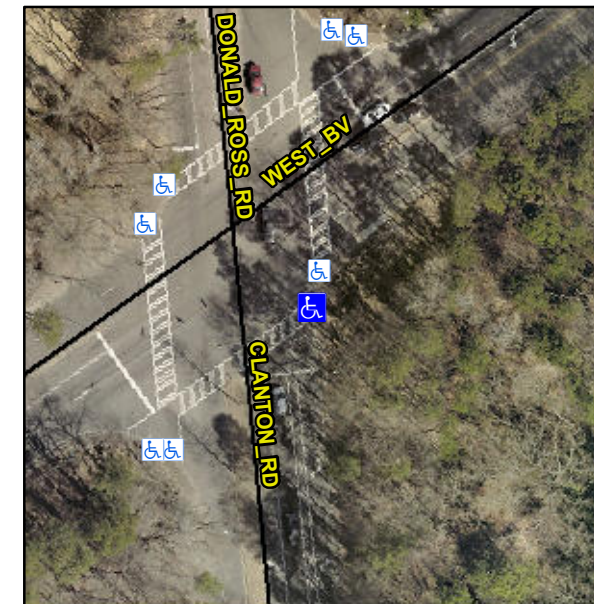
R304.2.2, R304.5.3

Compliance	Description	Data	Compliance	Description	Data
N/A	Ramp Length (in)	60.0	No	Ramp Slope (%)	13.2
Yes	Ramp Width (in)	60.0	No	Ramp XSlope (%)	4.0
N/A	Flare Type LT	N/A	N/A	Flare Type RT	N/A
N/A	Flare Slope LT (%)	N/A	N/A	Flare Slope RT (%)	N/A
N/A	Flare Traversable LT?	N/A	N/A	Flare Traversable RT?	N/A
N/A	Landing Length (in)	N/A	N/A	DWS Provided?	N/A
N/A	Landing Width (in)	N/A	N/A	DWS Contrast?	N/A
N/A	Landing Slope (%)	N/A	N/A	DWS Length (in)	N/A
N/A	Landing X Slope (%)	N/A	N/A	DWS Full Width?	N/A
N/A	Landing Curb? (Y/N)	N/A	N/A	DWS Offset (in)	N/A
N/A	Shared Landing?	N/A			
N/A	Gutter Ponding?	N/A	N/A	Gutter Slope (%)	N/A
N/A	Gutter Lip Ht (in)	N/A	N/A	Gutter X Slope (%)	N/A
N/A	Painted X Walk1?	Yes	N/A	Painted X Walk2?	N/A
	X Walk 1 Direction	To W		X Walk 2 Direction	N/A
N/A	X Walk 1 Width (in)	90.0	N/A	X Walk 2 Width (in)	N/A
	X Walk 1 Slope (%)	1.4		X Walk 2 Slope (%)	N/A
	X Walk 1 X Slope (%)	3.5		X Walk 2 X Slope (%)	N/A

N/A	Ramp inside XWalk1?	Yes	N/A	Ramp inside XWalk2?	N/A
	Road Slope (%)	N/A	N/A	Clear Space?	N/A
	Road X Slope (%)	N/A	N/A	Clear Space to XWalk (in)	N/A
N/A	Any Obstructions?	N/A	N/A	Storm Grate/Utility Hazard?	N/A
	Obstruction Type			Storm Grate/Utility Type	
		N/A			N/A
		Yes		Surface Condition? (G/P)	Good

Remove & Replace Entire Ramp.

Total Cost: \$ 1850.00
