Access Compliance Report

Public Rights-of-Way

(Curb Ramps)

Intersection ID: 3973	Main Street: MALLARD_CREEK_RD	Cross Street: W_MALLARD_CREEK_CHURCH_RD	Location: S
ADA ID: 3DD145D297C9	Ramp Type: Combination1	Initial Pass/Fail: Fail	Overall Compliance: No
			Severity Score: 26.25

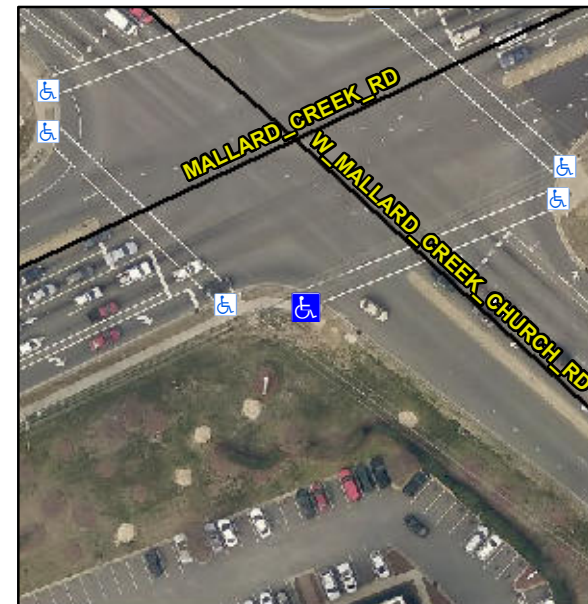
R304.2.2, R304.5.3, R304.3.2

Compliance	Description	Data	Compliance	Description	Data
N/A	Ramp Length LT (in)	65.0	N/A	Ramp Length RT (in)	55.0
Yes	Ramp Width LT (in)	59.0	Yes	Ramp Width RT (in)	59.0
Yes	Ramp Slope LT (%)	6.1	No	Ramp Slope RT (%)	8.4
No	Ramp XSlope LT (%)	2.7	No	Ramp XSlope RT (%)	2.2
N/A	Ramp Length (in)	62.0	No	Ramp Slope (%)	15.9
Yes	Ramp Width (in)	50.0	Yes	Ramp XSlope (%)	0.6
N/A	Flare Type LT	N/A	N/A	Flare Type RT	N/A
N/A	Flare Slope LT (%)	N/A	N/A	Flare Slope RT (%)	N/A
N/A	Flare Traversable LT?	N/A	N/A	Flare Traversable RT?	N/A
N/A	Landing Length (in)	N/A	N/A	DWS Provided?	N/A
N/A	Landing Width (in)	N/A	N/A	DWS Contrast?	N/A
N/A	Landing Slope (%)	N/A	N/A	DWS Length (in)	N/A
N/A	Landing X Slope (%)	N/A	N/A	DWS Full Width?	N/A
N/A	Landing Curb? (Y/N)	N/A	N/A	DWS Offset (in)	N/A
N/A	Shared Landing?	N/A			
N/A	Gutter Ponding?	N/A	N/A	Gutter Slope (%)	N/A
N/A	Gutter Lip Ht (in)	N/A	N/A	Gutter X Slope (%)	N/A
N/A	Painted X Walk1?	Yes	N/A	Painted X Walk2?	N/A

X Walk 1 Direction	To NE		X Walk 2 Direction	N/A
	X Walk 1 Width (in)	108.0		X Walk 2 Width (in)	N/A
	X Walk 1 Slope (%)	1.8		X Walk 2 Slope (%)	N/A
	X Walk 1 X Slope (%)	1.4		X Walk 2 X Slope (%)	N/A
N/A	Ramp inside XWalk1?	Yes	N/A	Ramp inside XWalk2?	N/A
	Road Slope (%)	N/A		Clear Space?	N/A
	Road X Slope (%)	N/A	N/A	Clear Space to XWalk (in)	N/A
			N/A	Any Obstruction?	N/A
				Obstruction Type	N/A
			N/A	Storm Grate/Utility Hazard?	N/A
				Storm Grate/Utility Type	N/A
			Yes	Surface Condition? (G/P)	Good
				Curb Slope (%)	N/A

Remove & Replace Entire Ramp.
