# Access Compliance Report

## Public Rights-of-Way

### (Curb Ramps)

Intersection ID: 10405	Main Street: HERRIN_AV	Cross Street: OAKWOOD_AV	Location: NE
ADA ID: 3DE9691CBD30	Ramp Type: Perp	Initial Pass/Fail: Fail	Overall Compliance: No
		Severity Score: 22.5

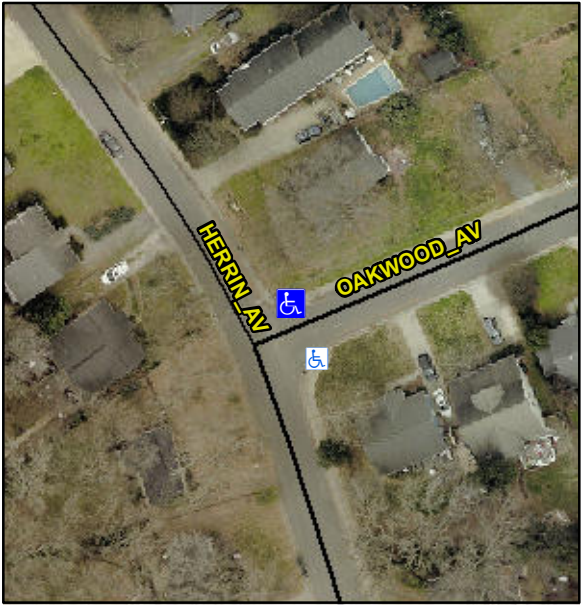
Possible Solutions:		<b>Compliance</b>	<b>Description</b>	<b>Data</b>
	<b>Remove &amp; Replace Entire Ramp.</b>		<b>No</b>	Ramp Length (in)	50.0
			<b>No</b>	Ramp Width (in)	47.5
			<b>N/A</b>	Flare Type LT	N/A
			<b>N/A</b>	Flare Slope LT (%)	N/A
			<b>N/A</b>	Flare Traversable LT?	N/A
			<b>N/A</b>	Landing Length (in)	N/A
			<b>N/A</b>	Landing Width (in)	N/A
			<b>N/A</b>	Landing Slope (%)	N/A
			<b>N/A</b>	Landing X Slope (%)	N/A
<p>Surveyor Notes:</p> <p><b>N/A</b></p> <p>PROW/ADA:</p> <p><b>Not Found, R304.5.1, R304.2.2, R304.5.3</b></p>			<b>N/A</b>	Flare Type RT	N/A
			<b>N/A</b>	Flare Slope RT (%)	N/A
			<b>N/A</b>	Flare Traversable RT?	N/A
			<b>N/A</b>	DWS Provided?	N/A
			<b>N/A</b>	DWS Contrast?	N/A
			<b>N/A</b>	DWS Length (in)	N/A
			<b>N/A</b>	DWS Full Width?	N/A
			<b>N/A</b>	DWS Offset (in)	N/A
			<b>N/A</b>	Shared Landing?	N/A
