Access Compliance Report

Public Rights-of-Way

(Curb Ramps)

Intersection ID: 18310	Main Street: VICKSBURG_RD	Cross Street: BATHURST_DR	Location: S
ADA ID: 3DF40AF2F4B8	Ramp Type: PerpDiag	Initial Pass/Fail: Fail	Overall Compliance: No
Severity Score: 22.5			
Codes/Mitigation Info/Possible Solution		Field Measurements/Component Compliance

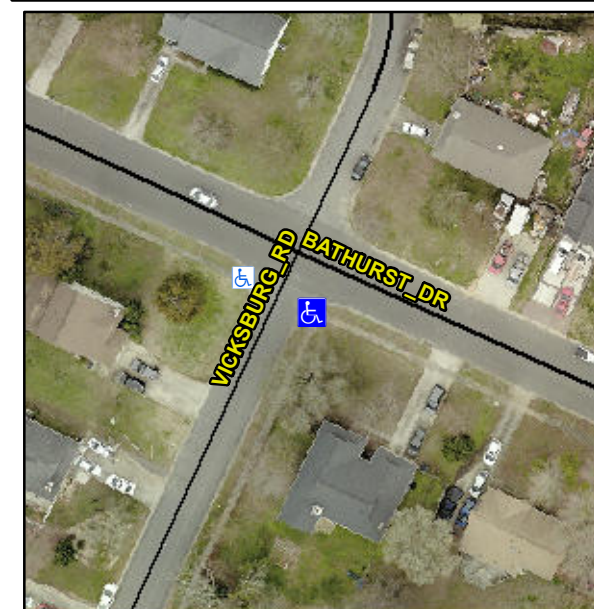
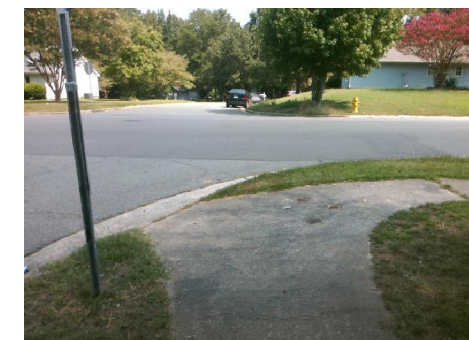
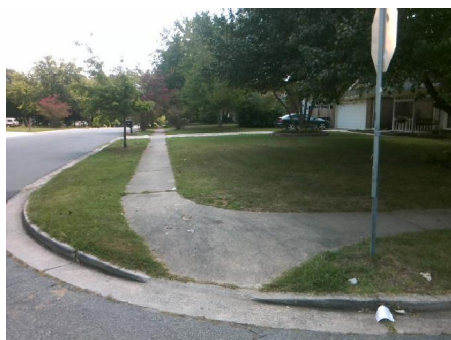
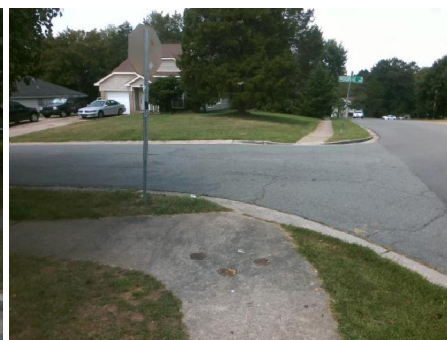
Not Found, R304.5.1, R304.2.2, R304.5.3

Compliance	Description	Data	Compliance	Description	Data
N/A	Ramp Length (in)	76.0	No	Ramp Slope (%)	9.4
No	Ramp Width (in)	46.0	No	Ramp XSlope (%)	4.0
N/A	Flare Type LT	N/A	N/A	Flare Type RT	N/A
N/A	Flare Slope LT (%)	N/A	N/A	Flare Slope RT (%)	N/A
N/A	Flare Traversable LT?	N/A	N/A	Flare Traversable RT?	N/A
N/A	Landing Length (in)	N/A	N/A	DWS Provided?	N/A
N/A	Landing Width (in)	N/A	N/A	DWS Contrast?	N/A
N/A	Landing Slope (%)	N/A	N/A	DWS Length (in)	N/A
N/A	Landing X Slope (%)	N/A	N/A	DWS Full Width?	N/A
N/A	Landing Curb? (Y/N)	N/A	N/A	DWS Offset (in)	N/A
N/A	Shared Landing?	N/A			
N/A	Gutter Ponding?	N/A	N/A	Gutter Slope (%)	N/A
N/A	Gutter Lip Ht (in)	N/A	N/A	Gutter X Slope (%)	N/A
N/A	Painted X Walk1?	No	N/A	Painted X Walk2?	No
	X Walk 1 Direction	To NE		X Walk 2 Direction	To NW
N/A	X Walk 1 Width (in)	N/A	N/A	X Walk 2 Width (in)	N/A
	X Walk 1 Slope (%)	3.0		X Walk 2 Slope (%)	1.4
	X Walk 1 X Slope (%)	0.4		X Walk 2 X Slope (%)	1.1

N/A	Ramp inside XWalk1?	N/A	N/A	Ramp inside XWalk2?	N/A
	Road Slope (%)	1.0	N/A	Clear Space?	N/A
	Road X Slope (%)	3.0	N/A	Clear Space to XWalk (in)	N/A
N/A	Any Obstructions?	N/A	N/A	Storm Grate/Utility Hazard?	N/A
	Obstruction Type			Storm Grate/Utility Type	
		N/A			N/A
			Yes	Surface Condition? (G/P)	Good

Remove & Replace Curb Ramp With Two New Directional Ramps or Equivalent.
