# Access Compliance Report

## Public Rights-of-Way

### (Curb Ramps)

Intersection ID: 27628	Main Street: BALLANTYNE COMMONS PY	Cross Street: ADAIR MANOR CT	Location: SE
ADA ID: 3DF6CBEE9543	Ramp Type: Perp	Initial Pass/Fail: Fail	Overall Compliance: No
Severity Score: 22.5			
Codes/Mitigation Info/Possible Solution		Field Measurements/Component Compliance

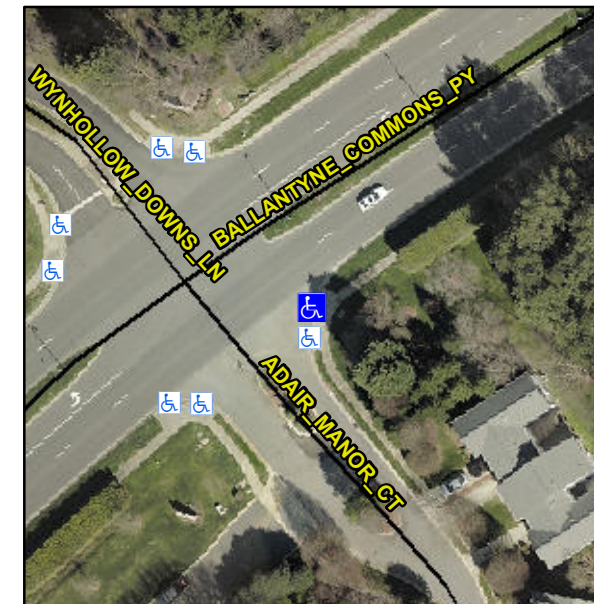
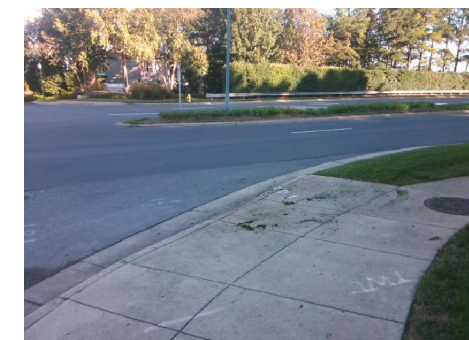
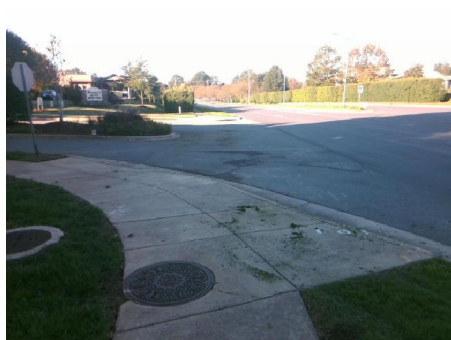
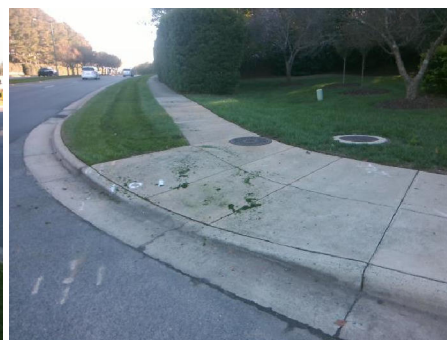
**Not Found, R304.5.1, R304.2.2, R304.5.3**

Compliance	Description	Data	Compliance	Description	Data
N/A	Ramp Length (in)	118.0	No	Ramp Slope (%)	8.8
No	Ramp Width (in)	41.0	No	Ramp XSlope (%)	4.5
N/A	Flare Type LT	N/A	N/A	Flare Type RT	N/A
N/A	Flare Slope LT (%)	N/A	N/A	Flare Slope RT (%)	N/A
N/A	Flare Traversable LT?	N/A	N/A	Flare Traversable RT?	N/A
N/A	Landing Length (in)	N/A	N/A	DWS Provided?	N/A
N/A	Landing Width (in)	N/A	N/A	DWS Contrast?	N/A
N/A	Landing Slope (%)	N/A	N/A	DWS Length (in)	N/A
N/A	Landing X Slope (%)	N/A	N/A	DWS Full Width?	N/A
N/A	Landing Curb? (Y/N)	N/A	N/A	DWS Offset (in)	N/A
N/A	Shared Landing?	N/A			
N/A	Gutter Ponding?	N/A	N/A	Gutter Slope (%)	N/A
N/A	Gutter Lip Ht (in)	N/A	N/A	Gutter X Slope (%)	N/A
N/A	Painted X Walk1?	No	N/A	Painted X Walk2?	N/A
	X Walk 1 Direction	To NW		X Walk 2 Direction	N/A
N/A	X Walk 1 Width (in)	N/A	N/A	X Walk 2 Width (in)	N/A
	X Walk 1 Slope (%)	4.0		X Walk 2 Slope (%)	N/A
	X Walk 1 X Slope (%)	2.4		X Walk 2 X Slope (%)	N/A

N/A	Ramp inside XWalk1?	N/A	N/A	Ramp inside XWalk2?	N/A
	Road Slope (%)	N/A	N/A	Clear Space?	N/A
	Road X Slope (%)	N/A	N/A	Clear Space to XWalk (in)	N/A
N/A	Any Obstructions?	N/A	N/A	Storm Grate/Utility Hazard?	N/A
	Obstruction Type			Storm Grate/Utility Type	
		N/A			N/A
			Yes	Surface Condition? (G/P)	Good

**Remove & Replace Entire Ramp.**
