Access Compliance Report Public Rights-of-Way (Curb Ramps)

•	-	-						
Intersection ID: N/A	Main Str	Main Street: TAMARACK DR			Street:	SINGLELEAF LN	Location:	S			
ADA ID: 3DF738AAFDCD	Ramp Type: Perp			Initial I	Pass/Fa	ail: Pass Overall	o Severity Score:	9.25			
Codes/Mitigation Info/Possible Solution					Field Measurements/Component Compliance						
A VI S MA	1.5%	Possible Solutions:		Compliance Description Data			Compliance Description		Data		
		Remove & Replace E	ntire Ramp).	N/A	Ramp Length (in)	48.0	Yes	Ramp Slope (%)	6.8

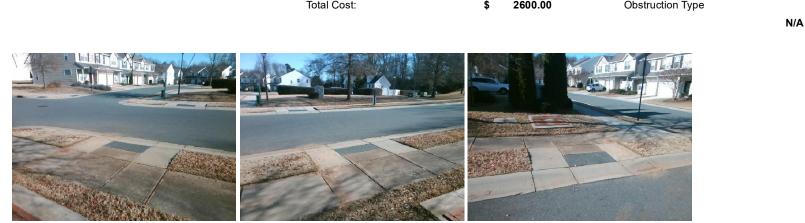
21.1	Remove & Replace G		-	Yes	Ramp Width (in)	48.0	Yes	Ramp XSlope (%)	3.2	
5. 61	1100				N/A	Flare Type LT	Sloped	N/A	Flare Type RT	N/A	
					N/A	Flare Slope LT (%)	6.3	N/A	Flare Slope RT (%)	2.3	
はたい	1 1				N/A	Flare Traversable LT?	No	N/A	Flare Traversable RT?	No	
6 S					No	Landing Length (in)	47.0	Yes	DWS Provided?	Yes	
	St 1/8-	Surveyor Notes:			No	Landing Width (in)	47.0	Yes	DWS Contrast?	Yes	
	a we have	N/A			Yes	Landing Slope (%)	0.6	Yes	DWS Length (in)	24.0	
	The second second				No	Landing X Slope (%)	4.0	Yes	DWS Full Width?	Yes	
and the second					N/A	Landing Curb? (Y/N)	No	Yes	DWS Offset (in)	0.0	
					N/A	Shared Landing?	No				
	Lord and	PROW/ADA:			Yes	Gutter Ponding?	No	No	Gutter Slope (%)	6.3	
Not Found, R30			R304.5.3.		Yes	Gutter Lip Ht (in)	0.0	Yes	Gutter X Slope (%)	1.9

K. C. R. W. K. K. K.	R304.5.4	,		N/A	Painted X Walk1?	No	N/A	Painted X Walk2?	N/A	
						X Walk 1 Direction	To NE		X Walk 2 Direction	N/A	
				N/A	X Walk 1 Width (in)	N/A	N/A	X Walk 2 Width (in)	N/A		
Street 1 Name	SINGLELEAF LN					X Walk 1 Slope (%)	4.1		X Walk 2 Slope (%)	N/A	
Stop Condition-Street 2	None					X Walk 1 X Slope (%)	3.7		X Walk 2 X Slope (%)	N/A	
Street 2 Name	N/A				N/A	Ramp inside XWalk1?	No	N/A	Ramp inside XWalk2?	N/A	
Stop Condition-Street 1	N/A					Road Slope (%)	N/A	N/A	Clear Space?	Yes	
						Road X Slope (%)	N/A	N/A	Clear Space to XWalk (in)	N/A	
					Yes	Any Obstructions?	No	Yes	Storm Grate/Utility Hazard?	No	
		Total Cost:	\$	2600.00		Obstruction Type			Storm Grate/Utility Type		
							N/A			N/A
