Access Compliance Report

Public Rights-of-Way

(Curb Ramps)

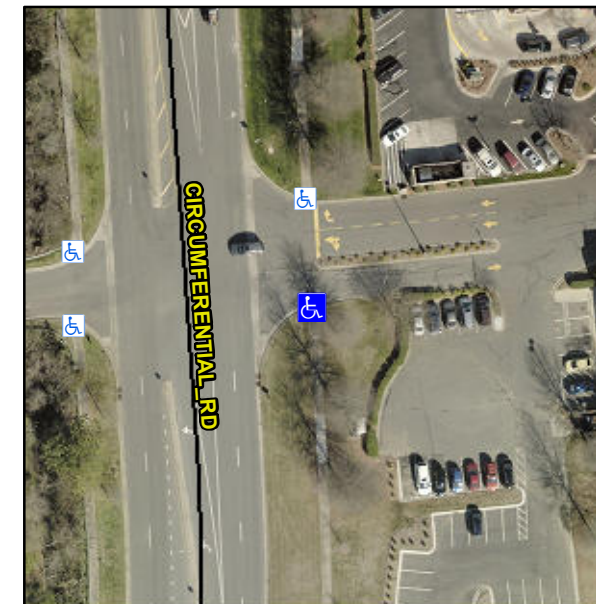
Intersection ID: 10023486	Main Street: CIRCUMFERENTIAL_RD	Cross Street: N/A	Location: SE
ADA ID: 3DFBCBB8D372	Ramp Type: Directional1	Initial Pass/Fail: Fail	Overall Compliance: No
Codes/Mitigation Info/Possible Solution		Field Measurements/Component Compliance	
Severity Score: 1.25

PROW/ADA:

R304.5.3

Compliance	Description	Data	Compliance	Description	Data
N/A	Ramp Length (in)	62.0	N/A	Grade Break?	N/A
Yes	Ramp Width (in)	58.0	N/A	Grade Break Slope (%)	0.0
Yes	Ramp Slope (%)	3.2	N/A	Grade Break XSlope (%)	0.0
No	Ramp XSlope (%)	2.3			
N/A	Flare Type LT	N/A	N/A	Flare Type RT	N/A
N/A	Flare Slope LT (%)	N/A	N/A	Flare Slope RT (%)	0.0
N/A	Flare Traversable LT?	N/A	N/A	Flare Traversable RT?	N/A
N/A	Landing Length (in)	0.0	N/A	DWS Provided?	N/A
N/A	Landing Width (in)	0.0	N/A	DWS Contrast?	N/A
N/A	Landing Slope (%)	0.0	N/A	DWS Length (in)	N/A
N/A	Landing X Slope (%)	0.0	N/A	DWS Full Width?	N/A
N/A	Landing Curb? (Y/N)	N/A	N/A	DWS Offset LT (in)	N/A
N/A	Shared Landing?	N/A	N/A	DWS Offset RT (in)	N/A
N/A	Gutter Ponding?	0.0	N/A	Gutter Slope (%)	N/A
N/A	Gutter Lip Ht (in)	0.0	N/A	Gutter X Slope (%)	N/A
N/A	Painted X Walk1?	No		Road Slope (%)	0.4
	X Walk 1 Direction	To N		Road X Slope (%)	3.6
	X Walk 1 Width (in)	N/A		Clear Space?	N/A

X Walk 1 Slope (%)	0.4	N/A	Clear Space to XWalk (in)	N/A
	X Walk 1 X Slope (%)	3.6	N/A	Storm Grate/Utility Hazard?	N/A
N/A	Ramp inside XWalk1?	N/A		Storm Grate/Utility Type	
N/A	Any Obstructions?	N/A			N/A
	Obstruction Type		Yes	Surface Condition? (G/P)	Good
			N/A	Curb Slope (%)	8.5

Possible Solutions:

Remove & Replace Entire Ramp.

Total Cost: \$ 1600.00
