# Access Compliance Report

## Public Rights-of-Way

### (Curb Ramps)

Intersection ID: 19542	Main Street: PROVIDENCE_RD	Cross Street: STRAWBERRY_HILL_DR	Location:	N
ADA ID: 3E0A79D35C06	Ramp Type: PerpDiag	Initial Pass/Fail: Fail	Overall Compliance: No	Severity Score: 22.5

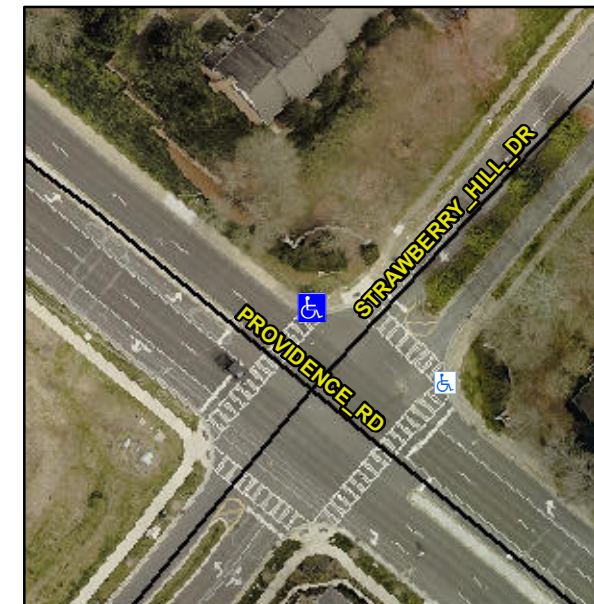
**Not Found, R304.5.1, R304.2.2, R304.5.3**

Compliance	Description	Data	Compliance	Description	Data
N/A	Ramp Length (in)	71.0	No	Ramp Slope (%)	9.0
No	Ramp Width (in)	41.0	No	Ramp XSlope (%)	4.6
N/A	Flare Type LT	N/A	N/A	Flare Type RT	N/A
N/A	Flare Slope LT (%)	N/A	N/A	Flare Slope RT (%)	N/A
N/A	Flare Traversable LT?	N/A	N/A	Flare Traversable RT?	N/A
N/A	Landing Length (in)	N/A	N/A	DWS Provided?	N/A
N/A	Landing Width (in)	N/A	N/A	DWS Contrast?	N/A
N/A	Landing Slope (%)	N/A	N/A	DWS Length (in)	N/A
N/A	Landing X Slope (%)	N/A	N/A	DWS Full Width?	N/A
N/A	Landing Curb? (Y/N)	N/A	N/A	DWS Offset (in)	N/A
N/A	Shared Landing?	N/A			
N/A	Gutter Ponding?	N/A	N/A	Gutter Slope (%)	N/A
N/A	Gutter Lip Ht (in)	N/A	N/A	Gutter X Slope (%)	N/A
N/A	Painted X Walk1?	No	N/A	Painted X Walk2?	No
	X Walk 1 Direction	To SW		X Walk 2 Direction	To SE
N/A	X Walk 1 Width (in)	N/A	N/A	X Walk 2 Width (in)	N/A
	X Walk 1 Slope (%)	0.9		X Walk 2 Slope (%)	5.2
	X Walk 1 X Slope (%)	3.7		X Walk 2 X Slope (%)	1.4

N/A	Ramp inside XWalk1?	N/A	N/A	Ramp inside XWalk2?	N/A
	Road Slope (%)	0.9	N/A	Clear Space?	N/A
	Road X Slope (%)	2.6	N/A	Clear Space to XWalk (in)	N/A
N/A	Any Obstructions?	N/A	N/A	Storm Grate/Utility Hazard?	N/A
	Obstruction Type			Storm Grate/Utility Type	
		N/A			N/A
			Yes	Surface Condition? (G/P)	Good

**Remove & Replace Curb Ramp With Two New Directional Ramps or Equivalent.**
