Access Compliance Report Public Rights-of-Way (Curb Ramps)

Intersection ID: 10036062 Main Street: RIVERGATE_PY Cross Street: N/A Location: NW ADA ID: 3E0B7169231C **Overall Compliance: No** Ramp Type: Perp Initial Pass/Fail: Fail Severity Score: 13.75

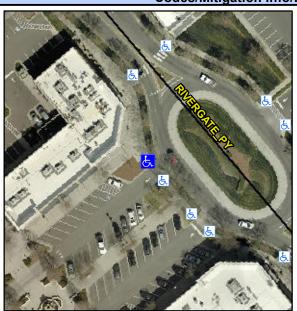
ООПІР	nance Description	Data	Odilip	nance Description	Data
N/A	Ramp Length (in)	43.0	No	Ramp Slope (%)	11.9
Yes	Ramp Width (in)	72.0	No	Ramp XSlope (%)	3.5
N/A	Flare Type LT	N/A	N/A	Flare Type RT	N/A
N/A	Flare Slope LT (%)	N/A	N/A	Flare Slope RT (%)	N/A
N/A	Flare Traversable LT?	N/A	N/A	Flare Traversable RT?	N/A
N/A	Landing Length (in)	N/A	N/A	DWS Provided?	N/A
N/A	Landing Width (in)	N/A	N/A DWS Contrast?		N/A
N/A	Landing Slope (%)	N/A	N/A DWS Length (in)		N/A
N/A	Landing X Slope (%)	N/A	N/A	DWS Full Width?	N/A
N/A	Landing Curb? (Y/N)	N/A	N/A	DWS Offset (in)	N/A
N/A	Shared Landing?	N/A			
N/A	Gutter Ponding?	N/A	N/A	Gutter Slope (%)	N/A
N/A	Gutter Lip Ht (in)	N/A	N/A	Gutter X Slope (%)	N/A
N/A	Painted X Walk1?	No	N/A	Painted X Walk2?	N/A
	X Walk 1 Direction	To SE		X Walk 2 Direction	N/A
N/A	X Walk 1 Width (in)	N/A	N/A	X Walk 2 Width (in)	N/A
	X Walk 1 Slope (%)	0.4		X Walk 2 Slope (%)	N/A
	X Walk 1 X Slope (%)	3.0		X Walk 2 X Slope (%)	N/A

Possible Solutions:						
Remove & Replace Entire Ramp.						
·						
Surveyor Notes:						
N/A						
PROW/ADA:						
R304.2.2, R304.5.3						
,
