# Access Compliance Report

## Public Rights-of-Way

### (Curb Ramps)

Intersection ID: 28370	Main Street: BRIDGEHAMPTON CLUB DR	Cross Street: SOUTHMOOR OAKS CT	Location: SW
ADA ID: 3E0EC01551CC	Ramp Type: Perp	Initial Pass/Fail: Fail	Overall Compliance: No
Severity Score: 1.25			
Codes/Mitigation Info/Possible Solution		Field Measurements/Component Compliance

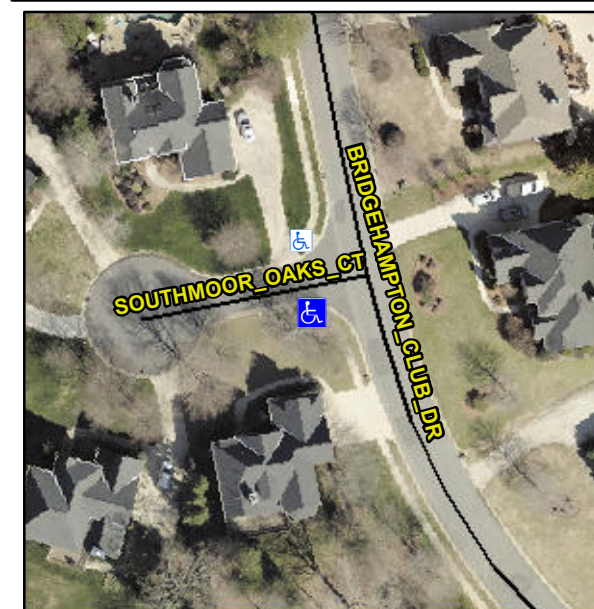
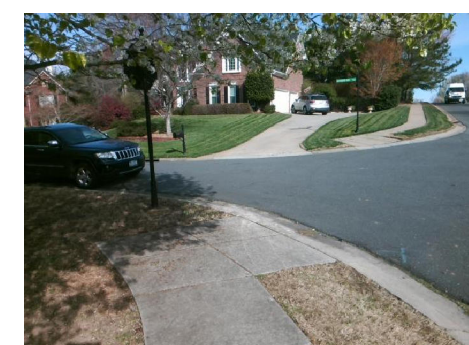
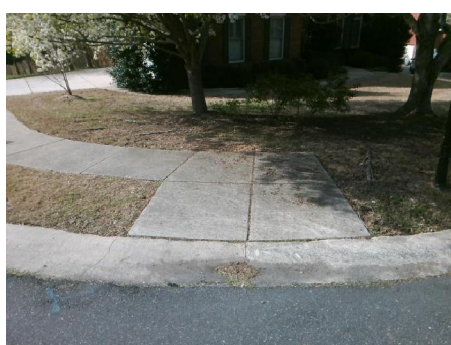
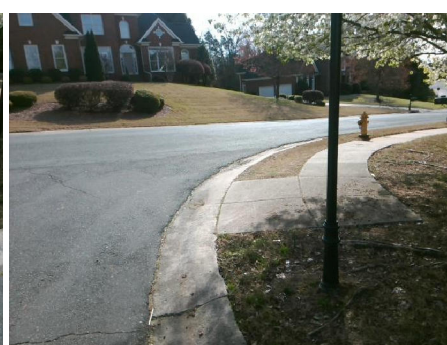
**Not Found, R304.5.3**

Compliance	Description	Data	Compliance	Description	Data
N/A	Ramp Length (in)	48.0	Yes	Ramp Slope (%)	5.4
Yes	Ramp Width (in)	48.0	No	Ramp XSlope (%)	2.6
N/A	Flare Type LT	N/A	N/A	Flare Type RT	N/A
N/A	Flare Slope LT (%)	N/A	N/A	Flare Slope RT (%)	N/A
N/A	Flare Traversable LT?	N/A	N/A	Flare Traversable RT?	N/A
N/A	Landing Length (in)	N/A	N/A	DWS Provided?	N/A
N/A	Landing Width (in)	N/A	N/A	DWS Contrast?	N/A
N/A	Landing Slope (%)	N/A	N/A	DWS Length (in)	N/A
N/A	Landing X Slope (%)	N/A	N/A	DWS Full Width?	N/A
N/A	Landing Curb? (Y/N)	N/A	N/A	DWS Offset (in)	N/A
N/A	Shared Landing?	N/A			
N/A	Gutter Ponding?	N/A	N/A	Gutter Slope (%)	N/A
N/A	Gutter Lip Ht (in)	N/A	N/A	Gutter X Slope (%)	N/A
N/A	Painted X Walk1?	No	N/A	Painted X Walk2?	N/A
	X Walk 1 Direction	To N		X Walk 2 Direction	N/A
N/A	X Walk 1 Width (in)	N/A	N/A	X Walk 2 Width (in)	N/A
	X Walk 1 Slope (%)	5.1		X Walk 2 Slope (%)	N/A
	X Walk 1 X Slope (%)	5.8		X Walk 2 X Slope (%)	N/A

N/A	Ramp inside XWalk1?	N/A	N/A	Ramp inside XWalk2?	N/A
	Road Slope (%)	N/A	N/A	Clear Space?	N/A
	Road X Slope (%)	N/A	N/A	Clear Space to XWalk (in)	N/A
N/A	Any Obstructions?	N/A	N/A	Storm Grate/Utility Hazard?	N/A
	Obstruction Type			Storm Grate/Utility Type	
		N/A			N/A
			Yes	Surface Condition? (G/P)	Good

**Remove & Replace Entire Ramp.**
