Access Compliance Report

Public Rights-of-Way

(Curb Ramps)

Intersection ID: 21209	Main Street: GALLERIA_BV	Cross Street: SARDIS_RD_NORTH	Location: W
ADA ID: 3E110AEA2534	Ramp Type: Perp	Initial Pass/Fail: Fail	Overall Compliance: No
		Severity Score: 10

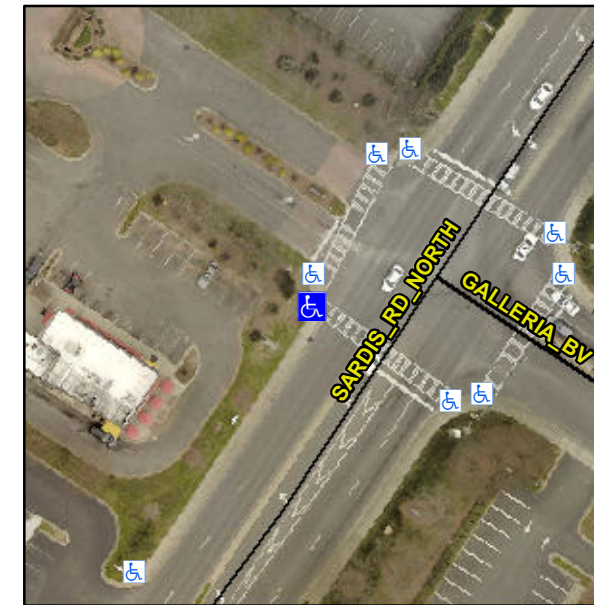
Not Found, R304.5.1, R304.5.3

Compliance	Description	Data	Compliance	Description	Data
N/A	Ramp Length (in)	69.0	Yes	Ramp Slope (%)	7.0
No	Ramp Width (in)	44.5	No	Ramp XSlope (%)	3.0
N/A	Flare Type LT	N/A	N/A	Flare Type RT	N/A
N/A	Flare Slope LT (%)	N/A	N/A	Flare Slope RT (%)	N/A
N/A	Flare Traversable LT?	N/A	N/A	Flare Traversable RT?	N/A
N/A	Landing Length (in)	N/A	N/A	DWS Provided?	N/A
N/A	Landing Width (in)	N/A	N/A	DWS Contrast?	N/A
N/A	Landing Slope (%)	N/A	N/A	DWS Length (in)	N/A
N/A	Landing X Slope (%)	N/A	N/A	DWS Full Width?	N/A
N/A	Landing Curb? (Y/N)	N/A	N/A	DWS Offset (in)	N/A
N/A	Shared Landing?	N/A			
N/A	Gutter Ponding?	N/A	N/A	Gutter Slope (%)	N/A
N/A	Gutter Lip Ht (in)	N/A	N/A	Gutter X Slope (%)	N/A
N/A	Painted X Walk1?	Yes	N/A	Painted X Walk2?	N/A
	X Walk 1 Direction	To SE		X Walk 2 Direction	N/A
N/A	X Walk 1 Width (in)	91.0	N/A	X Walk 2 Width (in)	N/A
	X Walk 1 Slope (%)	2.9		X Walk 2 Slope (%)	N/A
	X Walk 1 X Slope (%)	0.8		X Walk 2 X Slope (%)	N/A

N/A	Ramp inside XWalk1?	Yes	N/A	Ramp inside XWalk2?	N/A
	Road Slope (%)	N/A	N/A	Clear Space?	N/A
	Road X Slope (%)	N/A	N/A	Clear Space to XWalk (in)	N/A
N/A	Any Obstructions?	N/A	N/A	Storm Grate/Utility Hazard?	N/A
	Obstruction Type			Storm Grate/Utility Type	
		N/A			N/A
		Yes		Surface Condition? (G/P)	Good

Remove & Replace Entire Ramp.

Total Cost: \$ 1850.00
