Access Compliance Report

Public Rights-of-Way

(Curb Ramps)

Intersection ID: 50271	Main Street: CLANTON_RD	Cross Street: SOUTH_BV	Location: NW
ADA ID: 3E2A664FE834	Ramp Type: ParaDiag	Initial Pass/Fail: Fail	Overall Compliance: No
			Severity Score: 13.75

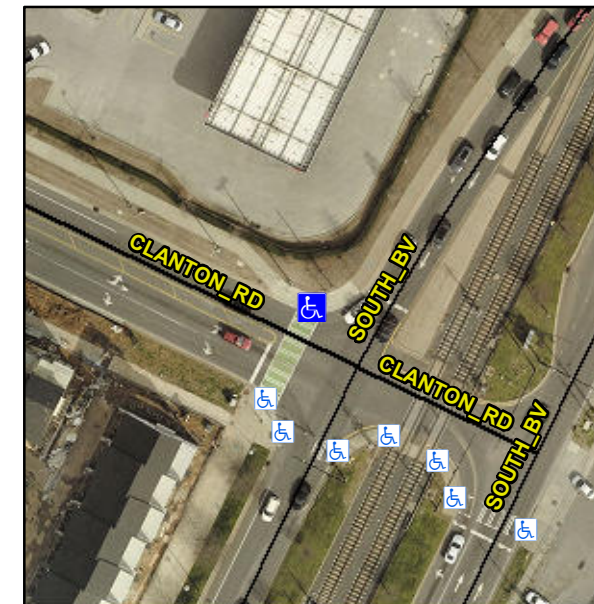
LT RP < 5%

Compliance	Description	Data	Compliance	Description	Data
N/A	Ramp Length LT (in)	89.0	N/A	Ramp Length RT (in)	108.0
Yes	Ramp Width LT (in)	83.0	Yes	Ramp Width RT (in)	83.0
Yes	Ramp Slope LT (%)	2.6	No	Ramp Slope RT (%)	8.7
Yes	Ramp XSlope LT (%)	1.9	No	Ramp XSlope RT (%)	3.8
N/A	Landing Length (in)	N/A	N/A	DWS Provided?	N/A
N/A	Landing Width (in)	N/A	N/A	DWS Contrast?	N/A
N/A	Landing Slope (%)	N/A	N/A	DWS Length (in)	N/A
N/A	Landing X Slope (%)	N/A	N/A	DWS Full Width?	N/A
N/A	Landing Curb? (Y/N)	N/A	N/A	DWS Offset (in)	N/A
N/A	Shared Landing?	N/A			
N/A	Gutter Ponding?	N/A	N/A	Gutter Slope (%)	N/A
N/A	Gutter Lip Ht (in)	N/A	N/A	Gutter X Slope (%)	N/A
N/A	Painted X Walk1?	Yes	N/A	Painted X Walk2?	No
	X Walk 1 Direction	To SW		X Walk 2 Direction	To SE
N/A	X Walk 1 Width (in)	152.0	N/A	X Walk 2 Width (in)	N/A
	X Walk 1 Slope (%)	2.5		X Walk 2 Slope (%)	0.8
	X Walk 1 X Slope (%)	2.3		X Walk 2 X Slope (%)	2.7
N/A	Ramp inside XWalk1?	Yes	N/A	Ramp inside XWalk2?	N/A

Road Slope (%)	1.0	N/A	Clear Space?	N/A
	Road X Slope (%)	1.7	N/A	Clear Space to XWalk (in)	N/A
N/A	Any Obstructions?	N/A	N/A	Storm Grate/Utility Hazard?	N/A
	Obstruction Type			Storm Grate/Utility Type	
		N/A			N/A
			Yes	Surface Condition? (G/P)	Good
			N/A	Curb Slope (%)	0.9

Possible Solutions:

Remove & Replace Curb Ramp With Two New Directional Ramps or Equivalent.
