Access Compliance Report

Public Rights-of-Way

(Curb Ramps)

Intersection ID: 9396	Main Street: MORETZ_AV	Cross Street: N_GRAHAM_ST	Location:	E
ADA ID: 3E2B18EA4F52	Ramp Type: Perp	Initial Pass/Fail: Fail	Overall Compliance: No	Severity Score: 37.5
Codes/Mitigation Info/Possible Solution		Field Measurements/Component Compliance

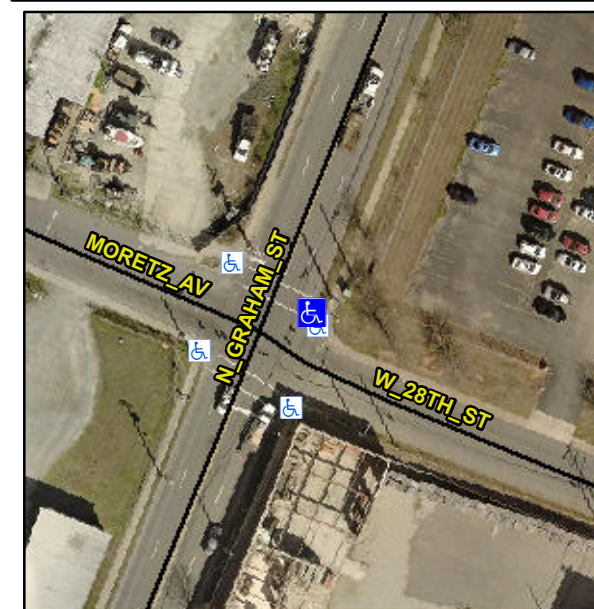
Compliance	Description	Data	Compliance	Description	Data
N/A	Ramp Length (in)	56.5	No	Ramp Slope (%)	9.8
No	Ramp Width (in)	44.0	No	Ramp XSlope (%)	3.7
N/A	Flare Type LT	N/A	N/A	Flare Type RT	N/A
N/A	Flare Slope LT (%)	N/A	N/A	Flare Slope RT (%)	N/A
N/A	Flare Traversable LT?	N/A	N/A	Flare Traversable RT?	N/A
N/A	Landing Length (in)	N/A	N/A	DWS Provided?	N/A
N/A	Landing Width (in)	N/A	N/A	DWS Contrast?	N/A
N/A	Landing Slope (%)	N/A	N/A	DWS Length (in)	N/A
N/A	Landing X Slope (%)	N/A	N/A	DWS Full Width?	N/A
N/A	Landing Curb? (Y/N)	N/A	N/A	DWS Offset (in)	N/A
N/A	Shared Landing?	N/A			
N/A	Gutter Ponding?	N/A	N/A	Gutter Slope (%)	N/A
N/A	Gutter Lip Ht (in)	2.0	N/A	Gutter X Slope (%)	N/A
N/A	Painted X Walk1?	Yes	N/A	Painted X Walk2?	N/A
	X Walk 1 Direction	To NW		X Walk 2 Direction	N/A
N/A	X Walk 1 Width (in)	111.5	N/A	X Walk 2 Width (in)	N/A
	X Walk 1 Slope (%)	2.2		X Walk 2 Slope (%)	N/A
	X Walk 1 X Slope (%)	1.4		X Walk 2 X Slope (%)	N/A

N/A	Ramp inside XWalk1?	Yes	N/A	Ramp inside XWalk2?	N/A
	Road Slope (%)	N/A	N/A	Clear Space?	N/A
	Road X Slope (%)	N/A	N/A	Clear Space to XWalk (in)	N/A
N/A	Any Obstructions?	N/A	N/A	Storm Grate/Utility Hazard?	N/A
	Obstruction Type			Storm Grate/Utility Type	
		N/A			N/A
		No		Surface Condition? (G/P)	Poor

Possible Solutions:

Remove & Replace Entire Ramp.

R304.5.1, R304.2.2, R304.5.3, R302.7
