Access Compliance Report

Public Rights-of-Way

(Curb Ramps)

Intersection ID: 50603	Main Street: RHODORA_RD	Cross Street: EMPRESS_CT	Location: SE
ADA ID: 3E3345FB31E6	Ramp Type: Perp	Initial Pass/Fail: Fail	Overall Compliance: No
Severity Score: 10			
Codes/Mitigation Info/Possible Solution		Field Measurements/Component Compliance

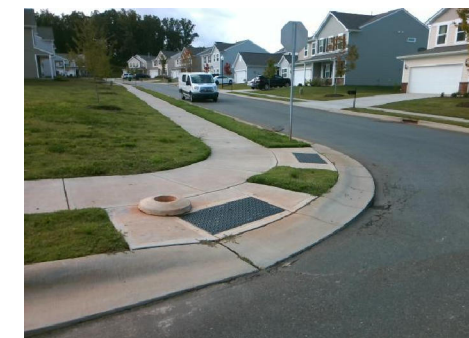
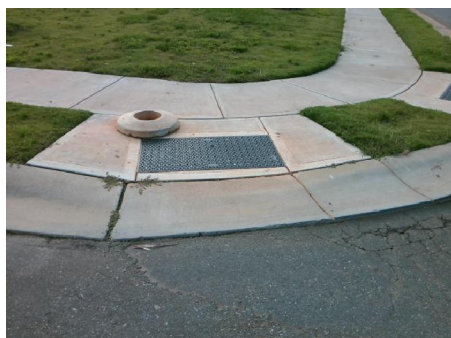
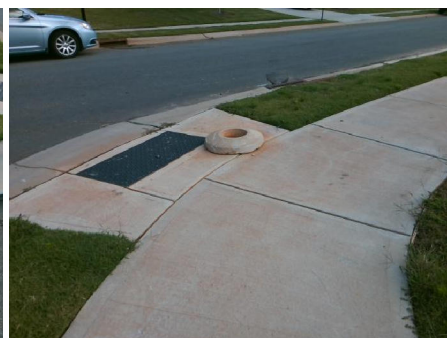
Not Found, R304.5.1, R304.5.3

Compliance	Description	Data	Compliance	Description	Data
N/A	Ramp Length (in)	47.5	Yes	Ramp Slope (%)	7.4
No	Ramp Width (in)	47.0	No	Ramp XSlope (%)	3.1
N/A	Flare Type LT	N/A	N/A	Flare Type RT	N/A
N/A	Flare Slope LT (%)	N/A	N/A	Flare Slope RT (%)	N/A
N/A	Flare Traversable LT?	N/A	N/A	Flare Traversable RT?	N/A
N/A	Landing Length (in)	N/A	N/A	DWS Provided?	N/A
N/A	Landing Width (in)	N/A	N/A	DWS Contrast?	N/A
N/A	Landing Slope (%)	N/A	N/A	DWS Length (in)	N/A
N/A	Landing X Slope (%)	N/A	N/A	DWS Full Width?	N/A
N/A	Landing Curb? (Y/N)	N/A	N/A	DWS Offset (in)	N/A
N/A	Shared Landing?	N/A			
N/A	Gutter Ponding?	N/A	N/A	Gutter Slope (%)	N/A
N/A	Gutter Lip Ht (in)	1.0	N/A	Gutter X Slope (%)	N/A
N/A	Painted X Walk1?	No	N/A	Painted X Walk2?	N/A
	X Walk 1 Direction	To N		X Walk 2 Direction	N/A
N/A	X Walk 1 Width (in)	N/A	N/A	X Walk 2 Width (in)	N/A
	X Walk 1 Slope (%)	1.4		X Walk 2 Slope (%)	N/A
	X Walk 1 X Slope (%)	2.7		X Walk 2 X Slope (%)	N/A

N/A	Ramp inside XWalk1?	N/A	N/A	Ramp inside XWalk2?	N/A
	Road Slope (%)	N/A	N/A	Clear Space?	N/A
	Road X Slope (%)	N/A	N/A	Clear Space to XWalk (in)	N/A
N/A	Any Obstructions?	N/A	N/A	Storm Grate/Utility Hazard?	N/A
	Obstruction Type			Storm Grate/Utility Type	
		N/A			N/A
			Yes	Surface Condition? (G/P)	Good

Possible Solutions:

Remove & Replace Entire Ramp.
