Access Compliance Report

Public Rights-of-Way

(Curb Ramps)

Intersection ID: 10038457	Main Street: SOUTHERN_PINE_BV	Cross Street: N/A	Location: S
ADA ID: 3E4EE840FFCC	Ramp Type: PerpDiag	Initial Pass/Fail: Fail	Overall Compliance: No
Codes/Mitigation Info/Possible Solution		Field Measurements/Component Compliance	
Severity Score: 26.25

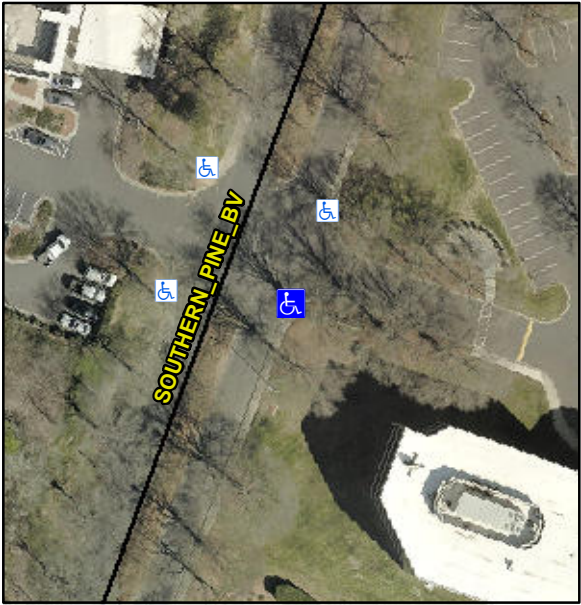
Possible Solutions:	Compliance	Description	Data	Compliance	Description	Data
	Remove & Replace Curb Ramp With Two New Directional Ramps or Equivalent.	N/A	Ramp Length (in)	48.0	No	Ramp Slope (%)	18.2
		Yes	Ramp Width (in)	48.0	No	Ramp XSlope (%)	4.6
		N/A	Flare Type LT	N/A	N/A	Flare Type RT	N/A
		N/A	Flare Slope LT (%)	N/A	N/A	Flare Slope RT (%)	N/A
		N/A	Flare Traversable LT?	N/A	N/A	Flare Traversable RT?	N/A
		N/A	Landing Length (in)	N/A	N/A	DWS Provided?	N/A
		N/A	Landing Width (in)	N/A	N/A	DWS Contrast?	N/A
		N/A	Landing Slope (%)	N/A	N/A	DWS Length (in)	N/A
		N/A	Landing X Slope (%)	N/A	N/A	DWS Full Width?	N/A
<p>Surveyor Notes:</p> <p>N/A</p> <p>PROW/ADA:</p> <p>Not Found, R304.2.2, R304.5.3</p>		N/A	Landing Curb? (Y/N)	N/A	N/A	DWS Offset (in)	N/A
		N/A	Shared Landing?	N/A			
		N/A	Gutter Ponding?	N/A	N/A	Gutter Slope (%)	N/A
		N/A	Gutter Lip Ht (in)	N/A	N/A	Gutter X Slope (%)	N/A
		N/A	Painted X Walk1?	No	N/A	Painted X Walk2?	No
