Access Compliance Report Public Rights-of-Way (Curb Ramps)

Intersection ID: 11943	Main Street: PEGRAM_ST	Cross Street: KENNON_ST	Location: S
ADA ID: 3E5D84CC9271	Ramp Type: Directional1	Initial Pass/Fail: Fail	Overall Compliance: No Severity Score: 12.5

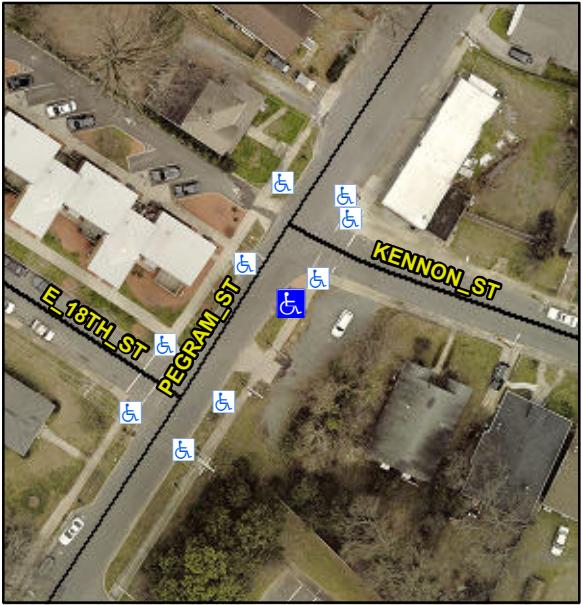
Surveyor Notes:
VEGETATION OVERGROWTH

Compliance	Description	Data	Compliance	Description	Data
N/A	Ramp Length (in)	90.0	N/A	Grade Break?	N/A
Yes	Ramp Width (in)	57.0	N/A	Grade Break Slope (%)	0.0
No	Ramp Slope (%)	8.5	N/A	Grade Break XSlope (%)	0.0
Yes	Ramp XSlope (%)	1.2			
N/A	Flare Type LT	N/A	N/A	Flare Type RT	N/A
N/A	Flare Slope LT (%)	N/A	N/A	Flare Slope RT (%)	0.0
N/A	Flare Traversable LT?	N/A	N/A	Flare Traversable RT?	N/A
N/A	Landing Length (in)	0.0	N/A	DWS Provided?	N/A
N/A	Landing Width (in)	0.0	N/A	DWS Contrast?	N/A
N/A	Landing Slope (%)	0.0	N/A	DWS Length (in)	N/A
N/A	Landing X Slope (%)	0.0	N/A	DWS Full Width?	N/A
N/A	Landing Curb? (Y/N)	N/A	N/A	DWS Offset LT (in)	N/A
N/A	Shared Landing?	N/A	N/A	DWS Offset RT (in)	N/A
N/A	Gutter Ponding?	Yes	N/A	Gutter Slope (%)	N/A
N/A	Gutter Lip Ht (in)	0.0	N/A	Gutter X Slope (%)	N/A
N/A	Painted X Walk1?	No		Road Slope (%)	2.2
	X Walk 1 Direction	To NW		Road X Slope (%)	3.3
	X Walk 1 Width (in)	N/A		Clear Space?	N/A

X Walk 1 Slope (%)	2.2	N/A	Clear Space to XWalk (in)	N/A
	X Walk 1 X Slope (%)	3.3	N/A	Storm Grate/Utility Hazard?	N/A
N/A	Ramp inside XWalk1?	N/A		Storm Grate/Utility Type	
N/A	Any Obstructions?	N/A			N/A
	Obstruction Type		Yes	Surface Condition? (G/P)	Good
			N/A	Curb Slope (%)	9.0

Possible Solutions:
Remove & Replace Entire Ramp.
