Access Compliance Report

Public Rights-of-Way

(Curb Ramps)

Intersection ID: N/A	Main Street: PATIMBY_RD	Cross Street: MCALPINE_PARK_DR	Location: SE
ADA ID: 3E618750D8F0	Ramp Type: PerpDiag	Initial Pass/Fail: Fail	Overall Compliance: No
Codes/Mitigation Info/Possible Solution		Field Measurements/Component Compliance

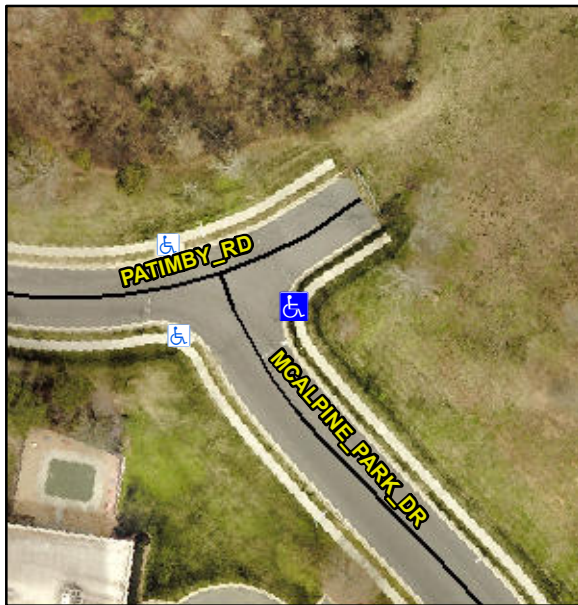
Not Found, R304.2.2, R304.5.3

Compliance	Description	Data	Compliance	Description	Data
N/A	Ramp Length (in)	48.0	No	Ramp Slope (%)	8.6
Yes	Ramp Width (in)	48.0	No	Ramp XSlope (%)	4.6
N/A	Flare Type LT	N/A	N/A	Flare Type RT	N/A
N/A	Flare Slope LT (%)	N/A	N/A	Flare Slope RT (%)	N/A
N/A	Flare Traversable LT?	N/A	N/A	Flare Traversable RT?	N/A
N/A	Landing Length (in)	N/A	N/A	DWS Provided?	N/A
N/A	Landing Width (in)	N/A	N/A	DWS Contrast?	N/A
N/A	Landing Slope (%)	N/A	N/A	DWS Length (in)	N/A
N/A	Landing X Slope (%)	N/A	N/A	DWS Full Width?	N/A
N/A	Landing Curb? (Y/N)	N/A	N/A	DWS Offset (in)	N/A
N/A	Shared Landing?	N/A			
N/A	Gutter Ponding?	N/A	N/A	Gutter Slope (%)	N/A
N/A	Gutter Lip Ht (in)	N/A	N/A	Gutter X Slope (%)	N/A
N/A	Painted X Walk1?	No	N/A	Painted X Walk2?	No
	X Walk 1 Direction	To N		X Walk 2 Direction	To W
N/A	X Walk 1 Width (in)	N/A	N/A	X Walk 2 Width (in)	N/A
	X Walk 1 Slope (%)	0.3		X Walk 2 Slope (%)	1.9
	X Walk 1 X Slope (%)	4.0		X Walk 2 X Slope (%)	1.6

N/A	Ramp inside XWalk1?	N/A	N/A	Ramp inside XWalk2?	N/A
	Road Slope (%)	2.7	N/A	Clear Space?	N/A
	Road X Slope (%)	1.8	N/A	Clear Space to XWalk (in)	N/A
N/A	Any Obstructions?	N/A	N/A	Storm Grate/Utility Hazard?	N/A
	Obstruction Type			Storm Grate/Utility Type	
		N/A			N/A
			Yes	Surface Condition? (G/P)	Good

Remove & Replace Curb Ramp With Two New Directional Ramps or Equivalent.
