Access Compliance Report

Public Rights-of-Way

(Curb Ramps)

Intersection ID: 30595	Main Street: LAMINGTON_RD	Cross Street: STONEMEDE_LN	Location: NW
ADA ID: 3E63FCE32F93	Ramp Type: PerpDiag	Initial Pass/Fail: Fail	Overall Compliance: No
		Severity Score: 10

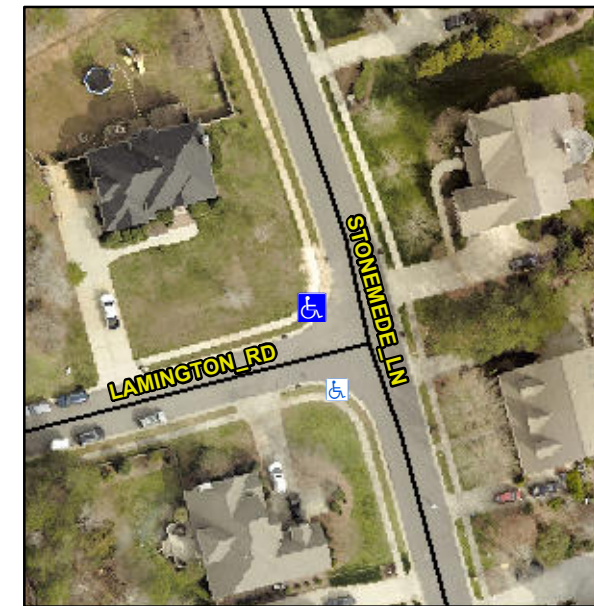
Compliance	Description	Data	Compliance	Description	Data
N/A	Ramp Length (in)	49.5	Yes	Ramp Slope (%)	5.0
No	Ramp Width (in)	44.5	No	Ramp XSlope (%)	4.4
N/A	Flare Type LT	N/A	N/A	Flare Type RT	N/A
N/A	Flare Slope LT (%)	N/A	N/A	Flare Slope RT (%)	N/A
N/A	Flare Traversable LT?	N/A	N/A	Flare Traversable RT?	N/A
N/A	Landing Length (in)	N/A	N/A	DWS Provided?	N/A
N/A	Landing Width (in)	N/A	N/A	DWS Contrast?	N/A
N/A	Landing Slope (%)	N/A	N/A	DWS Length (in)	N/A
N/A	Landing X Slope (%)	N/A	N/A	DWS Full Width?	N/A
N/A	Landing Curb? (Y/N)	N/A	N/A	DWS Offset (in)	N/A
N/A	Shared Landing?	N/A			
N/A	Gutter Ponding?	N/A	N/A	Gutter Slope (%)	N/A
N/A	Gutter Lip Ht (in)	N/A	N/A	Gutter X Slope (%)	N/A
N/A	Painted X Walk1?	No	N/A	Painted X Walk2?	No
	X Walk 1 Direction	To S		X Walk 2 Direction	To E
N/A	X Walk 1 Width (in)	N/A	N/A	X Walk 2 Width (in)	N/A
	X Walk 1 Slope (%)	0.2		X Walk 2 Slope (%)	2.6
	X Walk 1 X Slope (%)	4.8		X Walk 2 X Slope (%)	1.5

N/A	Ramp inside XWalk1?	N/A	N/A	Ramp inside XWalk2?	N/A
	Road Slope (%)	2.9	N/A	Clear Space?	N/A
	Road X Slope (%)	1.9	N/A	Clear Space to XWalk (in)	N/A
N/A	Any Obstructions?	N/A	N/A	Storm Grate/Utility Hazard?	N/A
	Obstruction Type			Storm Grate/Utility Type	
		N/A			N/A
		Yes		Surface Condition? (G/P)	Good

Remove & Replace Curb Ramp With Two New Directional Ramps or Equivalent.

Not Found, R304.5.1, R304.5.3
