# Access Compliance Report

## Public Rights-of-Way

### (Curb Ramps)

| ADA ID: 3E7A470D18D4 | Ramp Type: Directional1 | Initial Pass/Fail: Pass | Overall Compliance: No |

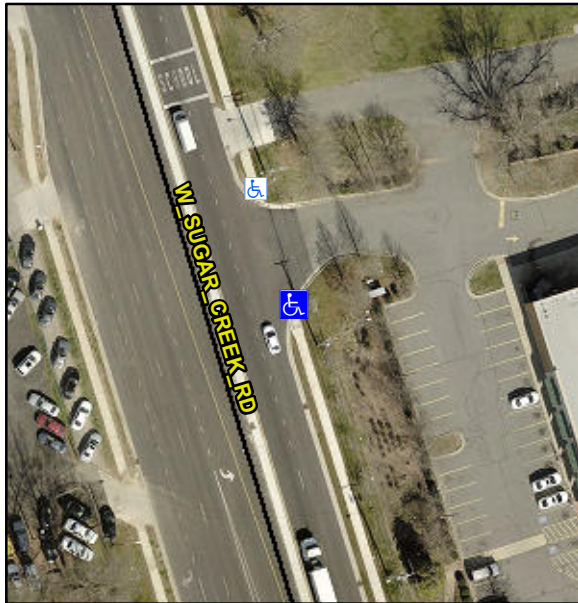
| Severity Score: 15.25 | | | |

PROW/ADA:

**R304.5.3, R305.2, R302.7.2**

| Compliance | Description | Data | Compliance | Description | Data |
|---|---|---|---|---|---|
| Yes | Ramp Slope (%) | 6.6 | No | Grade Break XSlope (%) | 3.9 |
| No | Ramp XSlope (%) | 4.4 | | | |
| No | Gutter Lip Ht (in) | 1.5 | Yes | Gutter X Slope (%) | 1.5 |

Possible Solutions:

**Remove & Replace Entire Ramp.  
Grind Gutter Lip.**
