Access Compliance Report

Public Rights-of-Way

(Curb Ramps)

Intersection ID: 30070	Main Street: SOUTHWIND_DR	Cross Street: WATERS_TRAIL_DR	Location: SW
ADA ID: 3E7F58D8EE46	Ramp Type: BlendTrans1	Initial Pass/Fail: Pass	Overall Compliance: No
Severity Score: 0			
Codes/Mitigation Info/Possible Solution		Field Measurements/Component Compliance

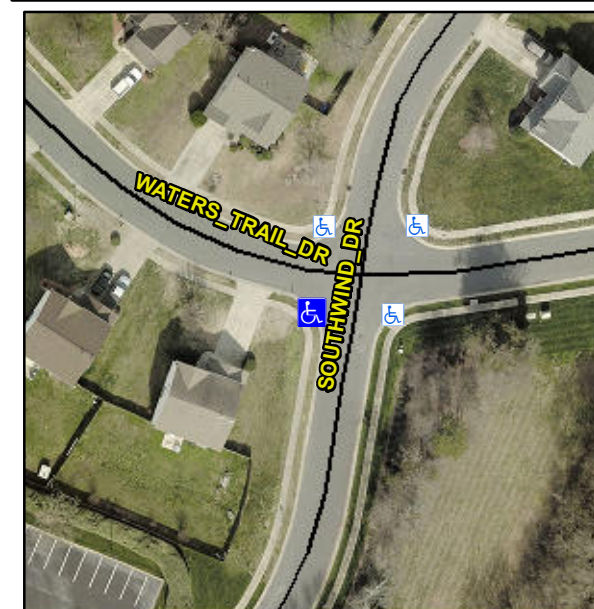
GTR GAP 2.0

Not Found, R304.2.1, R304.2.2-Perp, R304.3.2-Para, R305.2

Compliance	Description	Data	Compliance	Description	Data
N/A	Ramp Length (in)	51.0	Yes	BlendTrans Slope (%)	4.0
Yes	Ramp Width (in)	48.0	Yes	BlendTrans XSlope (%)	1.2
N/A	Flare Type LT	Sloped	N/A	Flare Type RT	Sloped
N/A	Flare Slope LT (%)	3.9	N/A	Flare Slope RT (%)	0.4
N/A	Flare Traversable LT?	No	N/A	Flare Traversable RT?	No
No	Landing Length (in)	43.0	Yes	DWS Provided?	Yes
Yes	Landing Width (in)	48.0	Yes	DWS Contrast?	Yes
No	Landing Slope (%)	2.3	Yes	DWS Length (in)	24.0
Yes	Landing X Slope (%)	0.1	Yes	DWS Full Width?	Yes
N/A	Landing Curb? (Y/N)	No	No	DWS Offset (in)	4.0
N/A	Shared Landing?	No			
Yes	Gutter Ponding?	No	Yes	Gutter Slope (%)	3.5
Yes	Gutter Lip Ht (in)	0.0	Yes	Gutter X Slope (%)	0.3
N/A	Painted X Walk1?	No	N/A	Painted X Walk2?	No
	X Walk 1 Direction	To E		X Walk 2 Direction	To N
	X Walk 1 Width (in)	N/A		X Walk 2 Width (in)	N/A
	X Walk 1 Slope (%)	3.8		X Walk 2 Slope (%)	0.3
	X Walk 1 X Slope (%)	1.2		X Walk 2 X Slope (%)	2.2

N/A	Ramp inside XWalk1?	N/A	N/A	Ramp inside XWalk2?	N/A
	Road Slope (%)	0.5		Clear Space?	Yes
	Road X Slope (%)	3.5	N/A	Clear Space to XWalk (in)	N/A
Yes	Any Obstructions?	No	Yes	Storm Grate/Utility Hazard?	No
	Obstruction Type			Storm Grate/Utility Type	
		N/A			N/A
			Yes	Surface Condition? (G/P)	Good
			No	Curb Slope (%)	9.1

Possible Solutions:

Remove & Replace Curb Ramp With Two New Directional Ramps or Equivalent.
