Access Compliance Report

Public Rights-of-Way

(Curb Ramps)

Intersection ID: 10569	Main Street: PLYMOUTH_AV	Cross Street: BANCROFT_ST	Location: W
ADA ID: 3E8135FD7CF1	Ramp Type: Perp	Initial Pass/Fail: Fail	Overall Compliance: No
Codes/Mitigation Info/Possible Solution		Field Measurements/Component Compliance	
Severity Score: 37.5

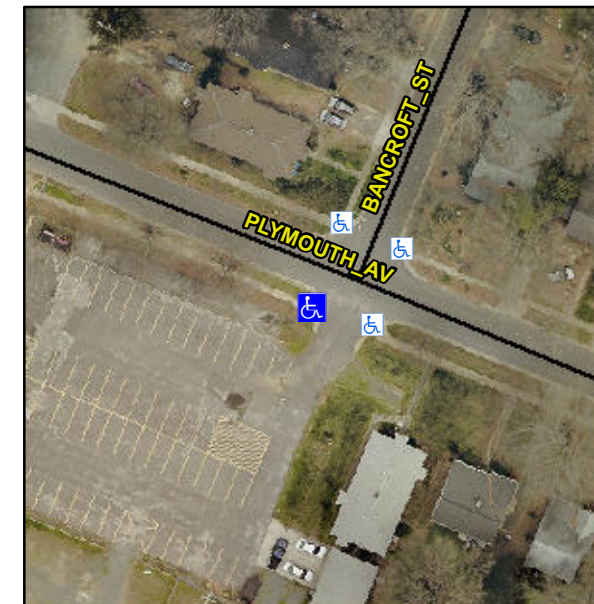
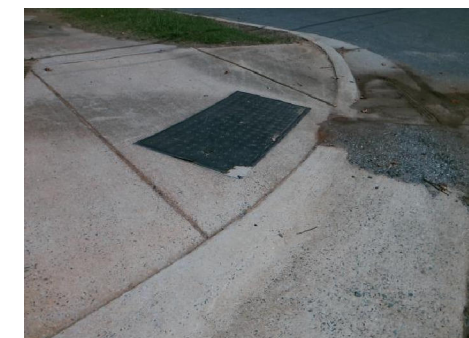
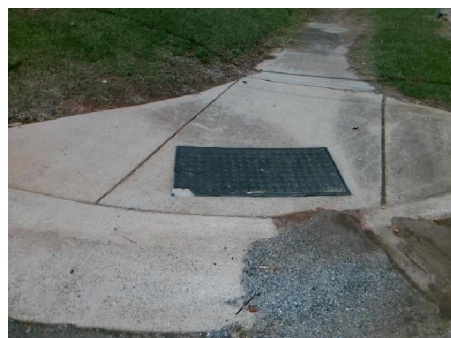
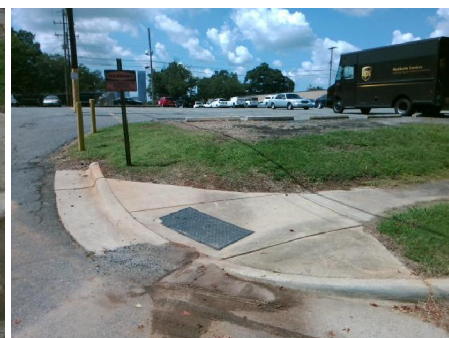
Not Found, R304.2.2, R304.5.3

Compliance	Description	Data	Compliance	Description	Data
N/A	Ramp Length (in)	86.0	No	Ramp Slope (%)	10.5
Yes	Ramp Width (in)	62.0	No	Ramp XSlope (%)	7.2
N/A	Flare Type LT	N/A	N/A	Flare Type RT	N/A
N/A	Flare Slope LT (%)	N/A	N/A	Flare Slope RT (%)	N/A
N/A	Flare Traversable LT?	N/A	N/A	Flare Traversable RT?	N/A
N/A	Landing Length (in)	N/A	N/A	DWS Provided?	N/A
N/A	Landing Width (in)	N/A	N/A	DWS Contrast?	N/A
N/A	Landing Slope (%)	N/A	N/A	DWS Length (in)	N/A
N/A	Landing X Slope (%)	N/A	N/A	DWS Full Width?	N/A
N/A	Landing Curb? (Y/N)	N/A	N/A	DWS Offset (in)	N/A
N/A	Shared Landing?	N/A			
N/A	Gutter Ponding?	Yes	N/A	Gutter Slope (%)	N/A
N/A	Gutter Lip Ht (in)	N/A	N/A	Gutter X Slope (%)	N/A
N/A	Painted X Walk1?	No	N/A	Painted X Walk2?	N/A
	X Walk 1 Direction	To SE		X Walk 2 Direction	N/A
N/A	X Walk 1 Width (in)	N/A	N/A	X Walk 2 Width (in)	N/A
	X Walk 1 Slope (%)	1.7		X Walk 2 Slope (%)	N/A
	X Walk 1 X Slope (%)	5.0		X Walk 2 X Slope (%)	N/A

N/A	Ramp inside XWalk1?	N/A	N/A	Ramp inside XWalk2?	N/A
	Road Slope (%)	N/A	N/A	Clear Space?	N/A
	Road X Slope (%)	N/A	N/A	Clear Space to XWalk (in)	N/A
N/A	Any Obstructions?	N/A	N/A	Storm Grate/Utility Hazard?	N/A
	Obstruction Type			Storm Grate/Utility Type	
		N/A			N/A
		Yes		Surface Condition? (G/P)	Good

Possible Solutions:

Remove & Replace Entire Ramp.
