# Access Compliance Report

## Public Rights-of-Way

### (Curb Ramps)

Intersection ID: 10751	Main Street: STATESVILLE_AV	Cross Street: OLIVER_ST	Location: NW
ADA ID: 3EB1BA0A7516	Ramp Type: Perp	Initial Pass/Fail: Fail	Overall Compliance: No
Severity Score: 8.75			
Codes/Mitigation Info/Possible Solution		Field Measurements/Component Compliance

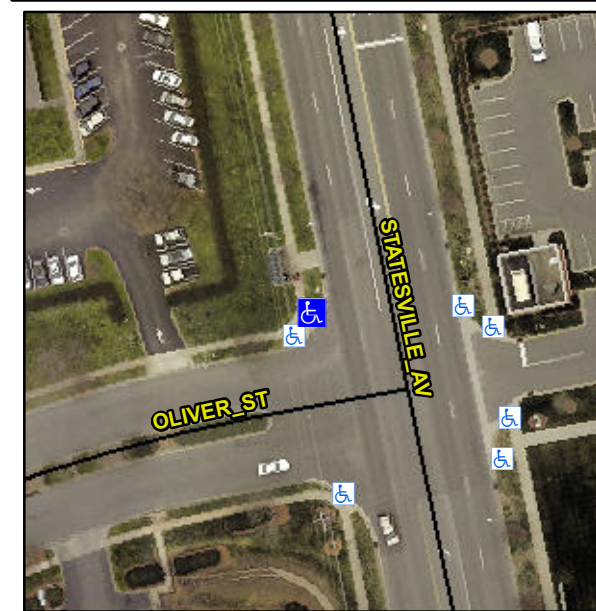
**Not Found, R304.5.1**

Compliance	Description	Data	Compliance	Description	Data
N/A	Ramp Length (in)	73.0	Yes	Ramp Slope (%)	8.3
No	Ramp Width (in)	44.0	Yes	Ramp XSlope (%)	0.4
N/A	Flare Type LT	N/A	N/A	Flare Type RT	N/A
N/A	Flare Slope LT (%)	N/A	N/A	Flare Slope RT (%)	N/A
N/A	Flare Traversable LT?	N/A	N/A	Flare Traversable RT?	N/A
N/A	Landing Length (in)	N/A	N/A	DWS Provided?	N/A
N/A	Landing Width (in)	N/A	N/A	DWS Contrast?	N/A
N/A	Landing Slope (%)	N/A	N/A	DWS Length (in)	N/A
N/A	Landing X Slope (%)	N/A	N/A	DWS Full Width?	N/A
N/A	Landing Curb? (Y/N)	N/A	N/A	DWS Offset (in)	N/A
N/A	Shared Landing?	N/A			
N/A	Gutter Ponding?	Yes	N/A	Gutter Slope (%)	N/A
N/A	Gutter Lip Ht (in)	0.5	N/A	Gutter X Slope (%)	N/A
N/A	Painted X Walk1?	No	N/A	Painted X Walk2?	N/A
	X Walk 1 Direction	To E		X Walk 2 Direction	N/A
N/A	X Walk 1 Width (in)	N/A	N/A	X Walk 2 Width (in)	N/A
	X Walk 1 Slope (%)	3.3		X Walk 2 Slope (%)	N/A
	X Walk 1 X Slope (%)	0.9		X Walk 2 X Slope (%)	N/A

N/A	Ramp inside XWalk1?	N/A	N/A	Ramp inside XWalk2?	N/A
	Road Slope (%)	N/A	N/A	Clear Space?	N/A
	Road X Slope (%)	N/A	N/A	Clear Space to XWalk (in)	N/A
N/A	Any Obstructions?	N/A	N/A	Storm Grate/Utility Hazard?	N/A
	Obstruction Type			Storm Grate/Utility Type	
		N/A			N/A
		Yes		Surface Condition? (G/P)	Good

**Remove & Replace Entire Ramp.**

Total Cost: \$ 1850.00
