Access Compliance Report

Public Rights-of-Way

(Curb Ramps)

Intersection ID: 11892	Main Street: BOYER_ST	Cross Street: TAGGART_CREEK_RD	Location: NE
ADA ID: 3EBA8483E241	Ramp Type: Perp	Initial Pass/Fail: Fail	Overall Compliance: No
			Severity Score: 13.75

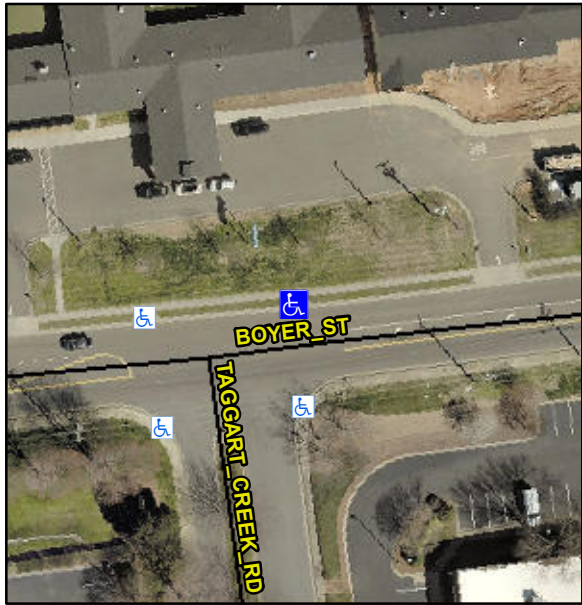
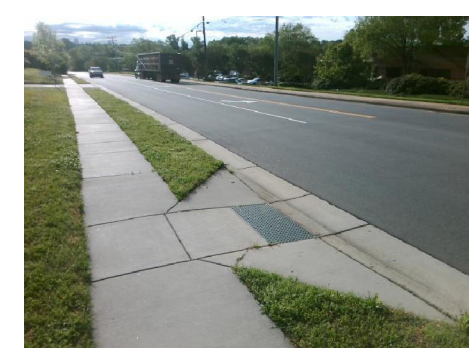
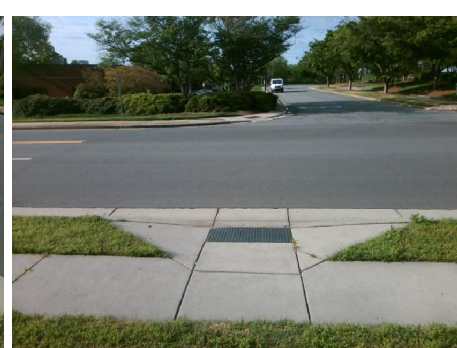
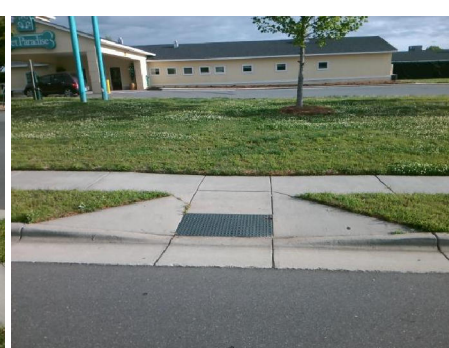
Possible Solutions:		Compliance			Description			Data	Compliance			Description			Data
	Remove & Replace Entire Ramp.		N/A	Ramp Length (in)			60.0			No	Ramp Slope (%)			9.2		
			Yes	Ramp Width (in)			48.0			No	Ramp XSlope (%)			3.0		
			N/A	Flare Type LT			N/A			N/A	Flare Type RT			N/A		
			N/A	Flare Slope LT (%)			N/A			N/A	Flare Slope RT (%)			N/A		
			N/A	Flare Traversable LT?			N/A			N/A	Flare Traversable RT?			N/A		
			N/A	Landing Length (in)			N/A			N/A	DWS Provided?			N/A		
			N/A	Landing Width (in)			N/A			N/A	DWS Contrast?			N/A		
			N/A	Landing Slope (%)			N/A			N/A	DWS Length (in)			N/A		
			N/A	Landing X Slope (%)			N/A			N/A	DWS Full Width?			N/A		
Surveyor Notes:		N/A	N/A			N/A			N/A	DWS Offset (in)			N/A			
PROW/ADA:		R304.2.2, R304.5.3	N/A			N/A			N/A	Gutter Ponding?			N/A			
			N/A			N/A			N/A	Gutter Lip Ht (in)			N/A
