Access Compliance Report

Public Rights-of-Way (Curb Ramps)

Intersection ID: 2832	Main Street: GOLDENFIELD_DR	Cross Street: DEARVIEW_LN	Location: S
ADA ID: 3EBB5C2972F4	Ramp Type: PerpDiag	Initial Pass/Fail: Fail	Overall Compliance: No
		Severity Score: 12.5

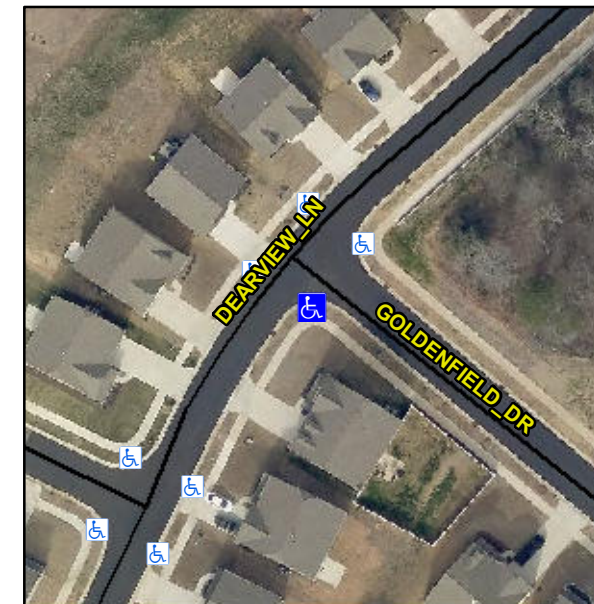
Not Found, R304.2.2

Compliance	Description	Data	Compliance	Description	Data
N/A	Ramp Length (in)	72.0	No	Ramp Slope (%)	8.4
Yes	Ramp Width (in)	48.0	Yes	Ramp XSlope (%)	0.4
N/A	Flare Type LT	N/A	N/A	Flare Type RT	N/A
N/A	Flare Slope LT (%)	N/A	N/A	Flare Slope RT (%)	N/A
N/A	Flare Traversable LT?	N/A	N/A	Flare Traversable RT?	N/A
N/A	Landing Length (in)	N/A	N/A	DWS Provided?	N/A
N/A	Landing Width (in)	N/A	N/A	DWS Contrast?	N/A
N/A	Landing Slope (%)	N/A	N/A	DWS Length (in)	N/A
N/A	Landing X Slope (%)	N/A	N/A	DWS Full Width?	N/A
N/A	Landing Curb? (Y/N)	N/A	N/A	DWS Offset (in)	N/A
N/A	Shared Landing?	N/A			
N/A	Gutter Ponding?	N/A	N/A	Gutter Slope (%)	N/A
N/A	Gutter Lip Ht (in)	N/A	N/A	Gutter X Slope (%)	N/A
N/A	Painted X Walk1?	No	N/A	Painted X Walk2?	No
	X Walk 1 Direction	To NE		X Walk 2 Direction	To NW
N/A	X Walk 1 Width (in)	N/A	N/A	X Walk 2 Width (in)	N/A
	X Walk 1 Slope (%)	0.7		X Walk 2 Slope (%)	0.7
	X Walk 1 X Slope (%)	2.2		X Walk 2 X Slope (%)	1.7

N/A	Ramp inside XWalk1?	N/A	N/A	Ramp inside XWalk2?	N/A
	Road Slope (%)	0.5	N/A	Clear Space?	N/A
	Road X Slope (%)	1.4	N/A	Clear Space to XWalk (in)	N/A
N/A	Any Obstructions?	N/A	N/A	Storm Grate/Utility Hazard?	N/A
	Obstruction Type			Storm Grate/Utility Type	
		N/A			N/A
			Yes	Surface Condition? (G/P)	Good

Remove & Replace Curb Ramp With Two New Directional Ramps or Equivalent.
