# Access Compliance Report

## Public Rights-of-Way

### (Curb Ramps)

| Intersection ID: 44118 | Main Street: CORAM_PL | Cross Street: RIDING_HILL_AV | Location: S |

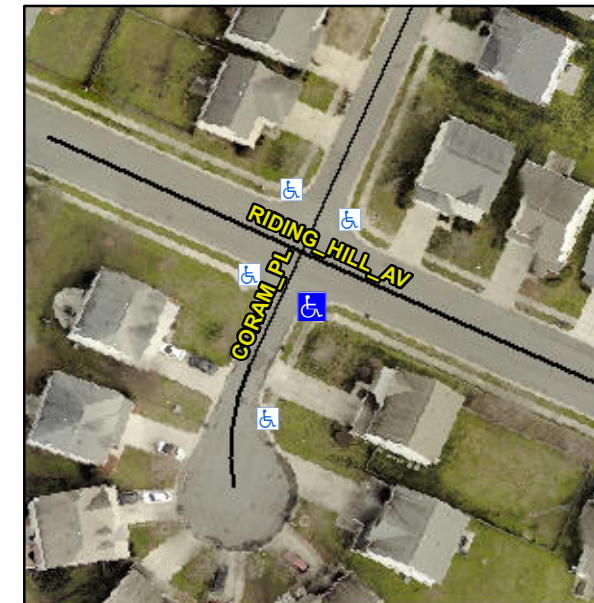
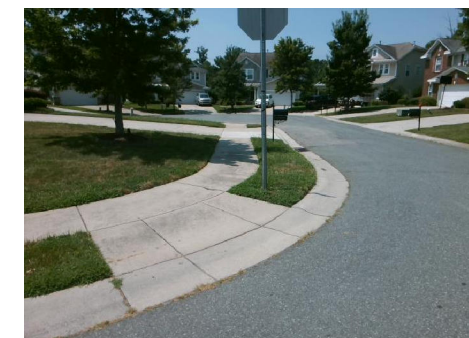
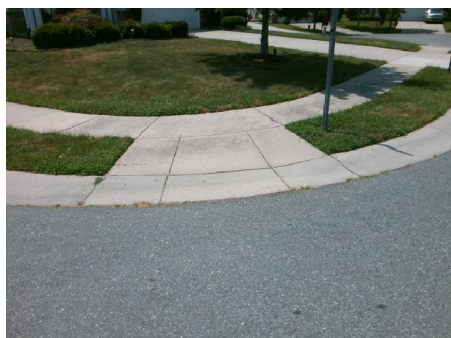
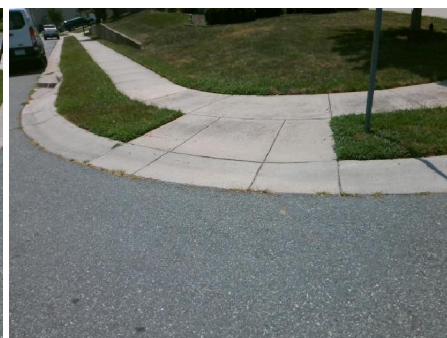
| ADA ID: 3ED9973CFB43 | Ramp Type: PerpDiag | Initial Pass/Fail: Fail | Overall Compliance: No |

**Not Found, R304.5.1, R304.5.3**

| Compliance | Description | Data | Compliance | Description | Data |
|---|---|---|---|---|---|
| No | Ramp Width (in) | 39.0 | No | Ramp XSlope (%) | 3.5 |

**Remove & Replace Curb Ramp With Two New Directional Ramps or Equivalent.**
