Access Compliance Report

Public Rights-of-Way

(Curb Ramps)

| Intersection ID: 13754 | Main Street: S_MCDOWELL_ST | Cross Street: BAXTER_ST | Location: S |

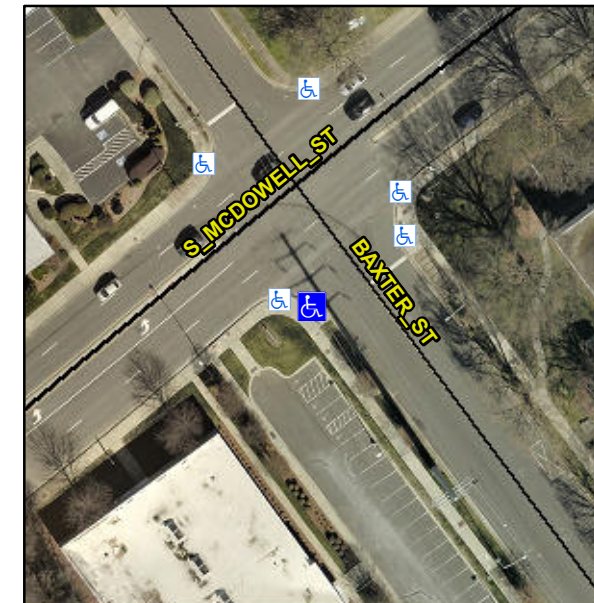
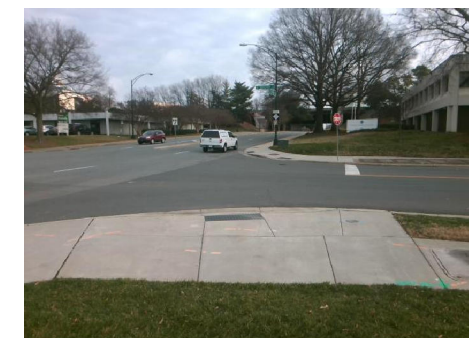
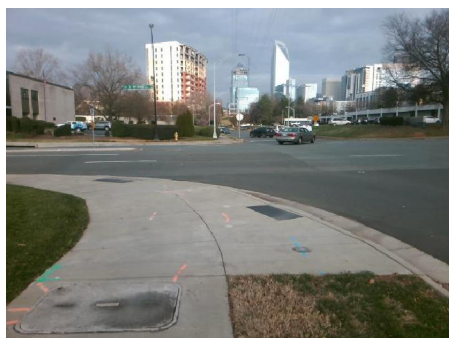
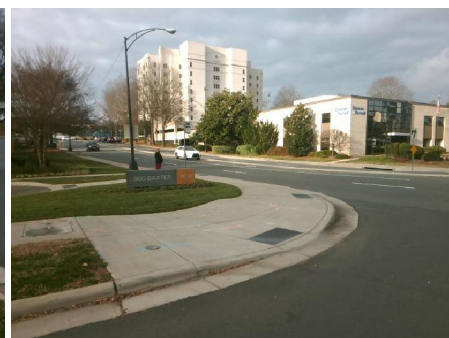
| ADA ID: 3EE892DB29BF | Ramp Type: Combination1 | Initial Pass/Fail: Fail | Overall Compliance: No |
| | | | Severity Score: 21.25 |

Not Found, R304.5.1, R304.3.2

| Compliance | Description | Data | Compliance | Description | Data |
|---|---|---|---|---|---|
| Yes | Ramp Slope LT (%) | 6.2 | No | Ramp Slope RT (%) | 10.6 |
| No | Ramp Width (in) | 47.0 | Yes | Ramp XSlope (%) | 1.3 |

Remove & Replace Entire Ramp.
