Access Compliance Report

Public Rights-of-Way

(Curb Ramps)

| Intersection ID: N/A | Main Street: GANNON_DR | Cross Street: RACHEL_FREEMAN_WY | Location: SE |

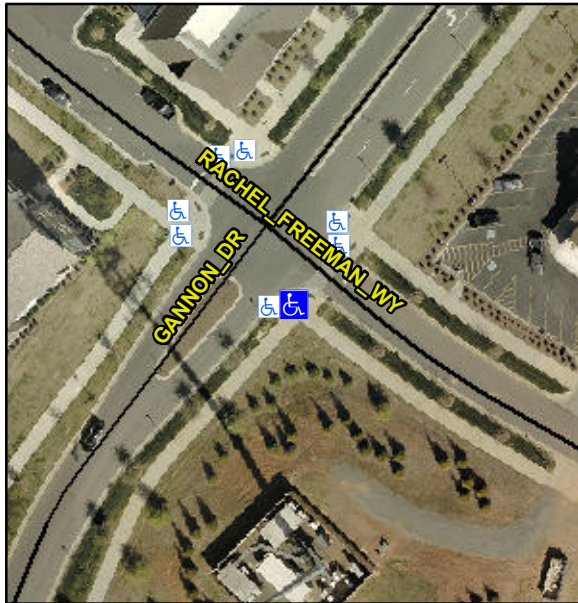
| Severity Score: 12.5 | | | |

Not Found, R304.2.2

| Compliance | Description | Data | Compliance | Description | Data |
|---|---|---|---|---|---|
| N/A | Ramp Length (in) | 98.5 | No | Ramp Slope (%) | 9.7 |

Remove & Replace Entire Ramp.
