Access Compliance Report

Public Rights-of-Way

(Curb Ramps)

Intersection ID: 18244	Main Street: CROSBY_RD	Cross Street: S_SHARON_AMITY_RD	Location: S
ADA ID: 3F18F418AEB1	Ramp Type: PerpDiag	Initial Pass/Fail: Fail	Overall Compliance: No
Severity Score: 22.5			
Codes/Mitigation Info/Possible Solution		Field Measurements/Component Compliance

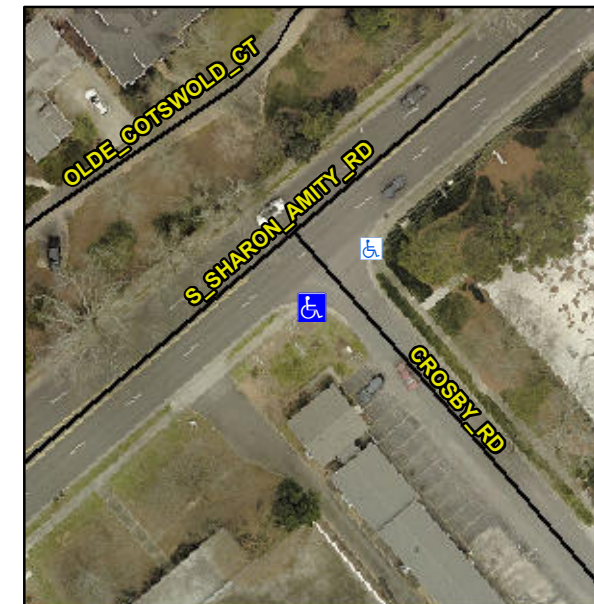
Not Found, R304.5.1, R304.2.2, R304.5.3

Compliance	Description	Data	Compliance	Description	Data
N/A	Ramp Length (in)	60.0	No	Ramp Slope (%)	8.9
No	Ramp Width (in)	37.0	No	Ramp XSlope (%)	4.3
N/A	Flare Type LT	N/A	N/A	Flare Type RT	N/A
N/A	Flare Slope LT (%)	N/A	N/A	Flare Slope RT (%)	N/A
N/A	Flare Traversable LT?	N/A	N/A	Flare Traversable RT?	N/A
N/A	Landing Length (in)	N/A	N/A	DWS Provided?	N/A
N/A	Landing Width (in)	N/A	N/A	DWS Contrast?	N/A
N/A	Landing Slope (%)	N/A	N/A	DWS Length (in)	N/A
N/A	Landing X Slope (%)	N/A	N/A	DWS Full Width?	N/A
N/A	Landing Curb? (Y/N)	N/A	N/A	DWS Offset (in)	N/A
N/A	Shared Landing?	N/A			
N/A	Gutter Ponding?	N/A	N/A	Gutter Slope (%)	N/A
N/A	Gutter Lip Ht (in)	N/A	N/A	Gutter X Slope (%)	N/A
N/A	Painted X Walk1?	No	N/A	Painted X Walk2?	No
	X Walk 1 Direction	To NE		X Walk 2 Direction	To NW
N/A	X Walk 1 Width (in)	N/A	N/A	X Walk 2 Width (in)	N/A
	X Walk 1 Slope (%)	2.2		X Walk 2 Slope (%)	0.4
	X Walk 1 X Slope (%)	1.1		X Walk 2 X Slope (%)	0.5

N/A	Ramp inside XWalk1?	N/A	N/A	Ramp inside XWalk2?	N/A
	Road Slope (%)	1.8	N/A	Clear Space?	N/A
	Road X Slope (%)	1.2	N/A	Clear Space to XWalk (in)	N/A
N/A	Any Obstructions?	N/A	N/A	Storm Grate/Utility Hazard?	N/A
	Obstruction Type			Storm Grate/Utility Type	
		N/A			N/A
			Yes	Surface Condition? (G/P)	Good

Possible Solutions:

Remove & Replace Curb Ramp With Two New Directional Ramps or Equivalent.
