# Access Compliance Report

## Public Rights-of-Way

| Intersection ID: 15013 | Main Street: E_WORTHINGTON_AV | Cross Street: EWING_AV | Location: NE |
| ADA ID: 3F2094A79C50 | Ramp Type: Perp | Initial Pass/Fail: Fail | Overall Compliance: No |

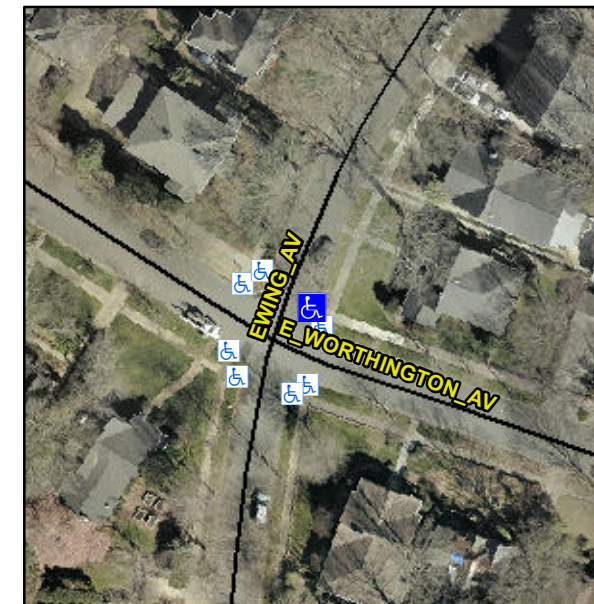
| | | Severity Score: 12.5 | |

**R304.5.3**

| Compliance | Description | Data | Compliance | Description | Data |
|---|---|---|---|---|---|
| Yes | Ramp Width (in) | 48.0 | No | Ramp XSlope (%) | 6.0 |

**Remove & Replace Entire Ramp.**

**\$ 1850.00**
