Access Compliance Report Public Rights-of-Way (Curb Ramps)

Intersection ID: 6285 Main Street: ALLEN_RD_EAST Cross Street: EARGLE_RD Location: SE

ADA ID: 3F2A531D4F1D Ramp Type: Perp Initial Pass/Fail: Fail Overall Compliance: No Severity Score: 42.5

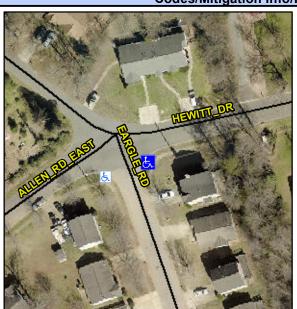
THE RESERVE OF THE PARTY OF THE	The state of the s
Street 1 Name	EARGLE RD
Stop Condition-Street 2	StopSign
Street 2 Name	N/A
Ston Condition-Street 1	N/A

Field Measurements/Component Compliance						
Comp	liance Description	Data	Comp	liance Description	Data	
N/A	Ramp Length (in)	49.0	Yes	Ramp Slope (%)	6.6	
No	Ramp Width (in)	35.0	No	Ramp XSlope (%)	13.4	
N/A	Flare Type LT	N/A	N/A	Flare Type RT	N/A	
N/A	Flare Slope LT (%)	N/A	N/A	Flare Slope RT (%)	N/A	
N/A	Flare Traversable LT?	N/A	N/A	Flare Traversable RT?	N/A	
N/A	Landing Length (in)	N/A	N/A	DWS Provided?	N/A	
N/A	Landing Width (in)	N/A	N/A	DWS Contrast?	N/A	
N/A	Landing Slope (%)	N/A	N/A	DWS Length (in)	N/A	
N/A	Landing X Slope (%)	N/A	N/A	DWS Full Width?	N/A	
N/A	Landing Curb? (Y/N)	N/A	N/A	DWS Offset (in)	N/A	
N/A	Shared Landing?	N/A				
N/A	Gutter Ponding?	N/A	N/A	Gutter Slope (%)	N/A	
N/A	Gutter Lip Ht (in)	0.5	N/A	Gutter X Slope (%)	N/A	
N/A	Painted X Walk1?	No	N/A	Painted X Walk2?	N/A	
	X Walk 1 Direction	To W		X Walk 2 Direction	N/A	
N/A	X Walk 1 Width (in)	N/A	N/A	X Walk 2 Width (in)	N/A	
	X Walk 1 Slope (%)	8.5		X Walk 2 Slope (%)	N/A

X Walk 1 X Slope (%)	3.5		X Walk 2 X Slope (%)	N/A	
N/A	Ramp inside XWalk1?	N/A	N/A	Ramp inside XWalk2?	N/A	
	Road Slope (%)	N/A	N/A	Clear Space?	N/A	
	Road X Slope (%)	N/A	N/A	Clear Space to XWalk (in)	N/A	
N/A	Any Obstructions?	N/A	N/A	Storm Grate/Utility Hazard?	N/A	
	Obstruction Type			Storm Grate/Utility Type		
		N/A			N/A	
			Yes	Surface Condition? (G/P)	Good

Possible Solutions:
Remove & Replace Entire Ramp.
•
Surveyor Notes:
N/A
PROW/ADA:
Not Found, R304.5.1, R304.5.3
•
